Date: January 9, 2024

Project No. 141.20174.00002

**RE: Wetland Violation Inspection Summary/Recommendations
Litchfield Hills KOA Campground
232 Klug Hill Road
Torrington, Connecticut**

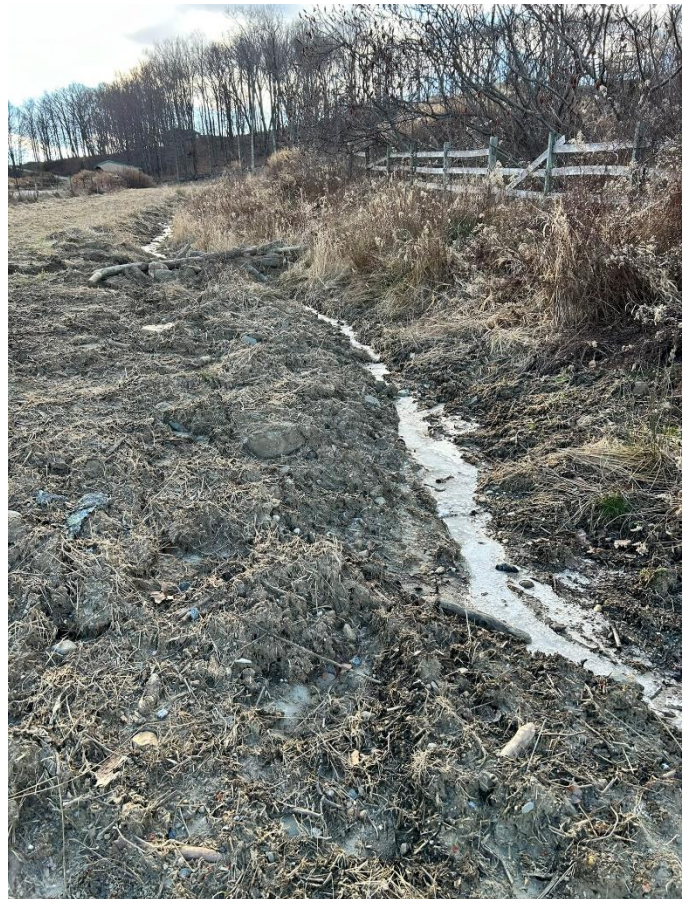
Old swale and recently disturbed farm field wetland

been permitted. During my visit, I noted that the old drainage swale still had some surface water present, albeit minor as compared to previous site inspections. It should be noted that this swale still receives groundwater seepage from adjacent uplands, which will support/maintain the wetland vegetation growing within the swale.

- Areas that have exposed soil should be seeded with a New England Erosion Control Seed mix for moist sites.
- The crushed stone within the old drainage swale should be covered with a thin layer of topsoil (less than 2 inches) to provide opportunities for revegetation.
- The new drainage swale should be formalized and graded to reduce erosion potential and flooding of the driveway entrance and Klug Hill Road. Round river stones can be used to formalize the channel (see attached Figure 1).

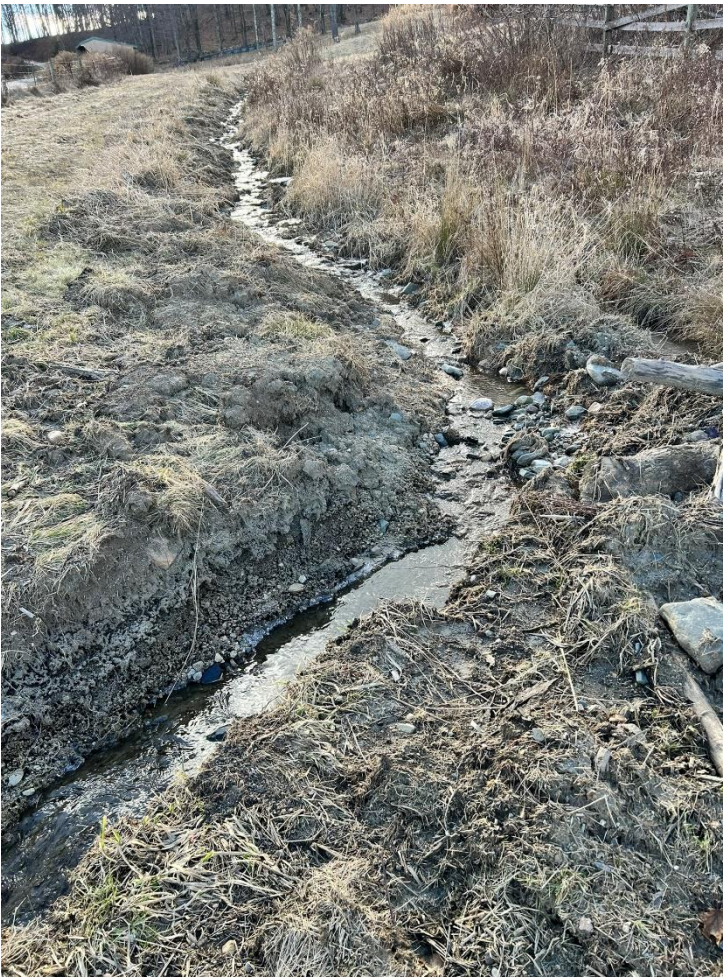
Wetland Violation Area No. 1 is located at the main entrance drive off Klug Hill Road. North of the existing driveway, SLR had previously delineated a farm field wetland and drainage swale that conveyed seasonally high groundwater seepages and stormwater surface runoff east into the right-of-way of Klug Hill Road. There is an Eversource utility pole located within the farm field wetland and is located within the city right-of-way. The landowner retained an electrician and general contractor to install a new electrical panel near the entrance driveway, and the panel was connected via underground utilities to the utility pole described above. During the installation of the panel and associated utility trenching, the existing wetland and swale were disturbed by the activities. In addition, the general contractor placed fill within the existing wetland and drainage swale to prevent water from flowing towards the utility pole and within its original channel. The fill placed within the swale included soil and woody debris and crushed stone (at the trench location). To convey surface water around the utility trench area, the contractor excavated a new drainage swale through the adjacent upland field and redirected surface water flows towards an existing driveway cross culvert. None of these activities had

New diversion swale cut into uplands, lower portion of photo. Debris dam placed in old drainage swale, lower right portion of photo.

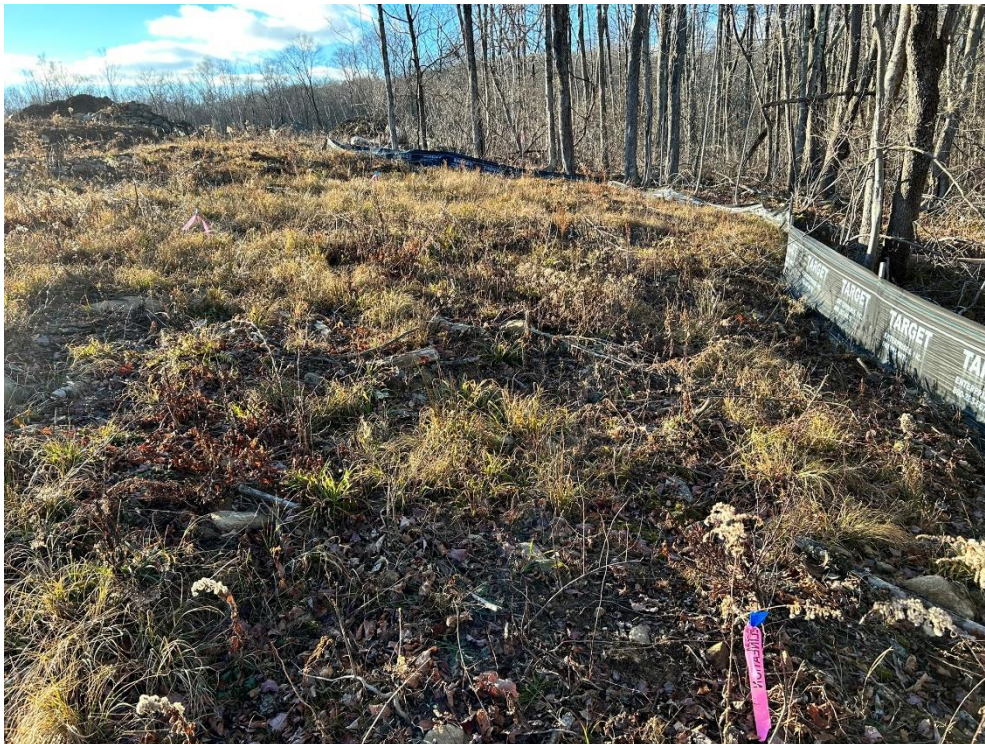
Wetland Violation Area No. 2 is located north of stormwater detention basin No. 310 and includes overclearing, grubbing, and installation of a geotextile silt fence within a regulated wetland. The general contractor cleared a small portion of a forested wetland during clearing and grubbing operations and installed the silt fence through the cleared wetland. The contractor grubbed the area within and adjacent to the wetland and disturbed a portion of the soil solum. This disturbance mixed some of the soil horizons, making the wetland boundary less definitive in the field than preconstruction conditions. SLR set new blue and pink wetland flags at this location based on current field conditions. The wetland area that was cleared is well vegetated with a variety of wetland herbaceous plants, including soft rush, sensitive fern, and sedges.

New wetland flags placed in field. Silt fence to be moved upgradient of newly set flags.

- Remove and relocate a segment of geotextile silt fence outside/upgradient of the wetland flags placed in January 2024. This includes approximately 60 linear feet of silt fence relocation (see Figure 2).
- Allow wetland to regrow naturally. No supplemental plantings are recommended.

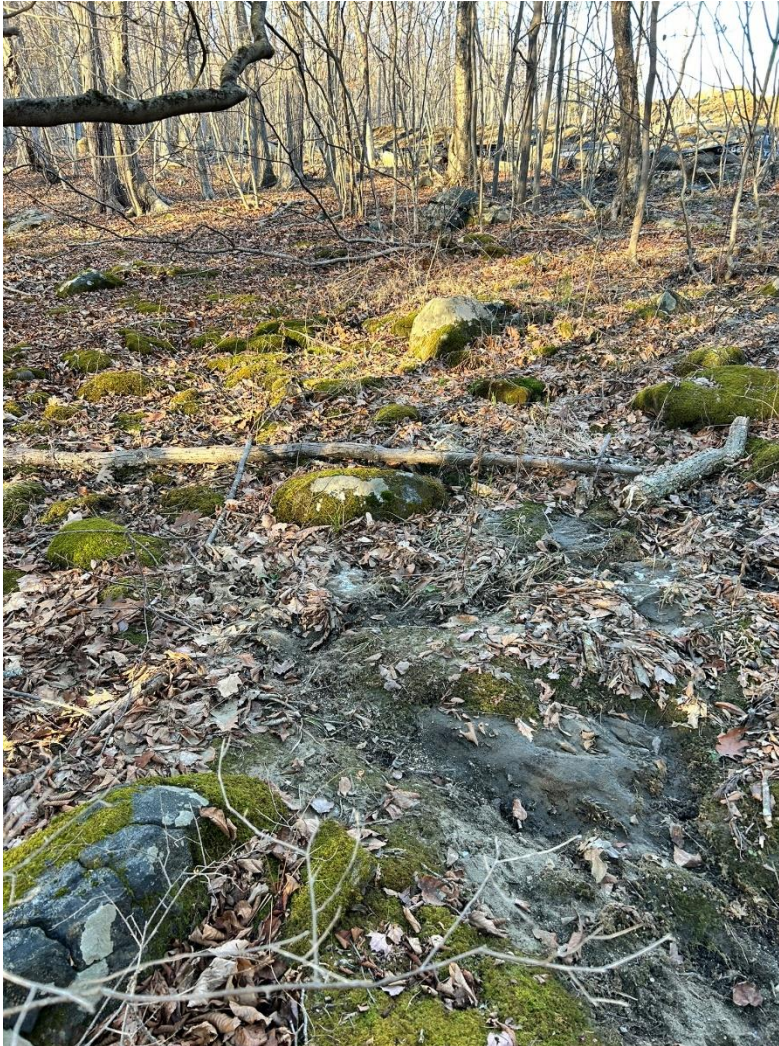
Wetland Violation Area No. 3 is located downgradient from stormwater detention basin No. 110. This basin has discharged sediment into the adjacent forested wetland. The silt fence located downgradient from the basin overtopped and likely breached during recent heavy rainstorms. The breach resulted in sediment being deposited on the wetland surface. Depths of sediment deposition range from 0.5 to 2.5 inches. The area of deposition is confined to a narrow, less than 8-foot-wide swath within the wetland. The sediment has deposited on the small depressions within the wetland. I did not observe any significant sediment deposits within the emergent wetland located downgradient from the forested wetland.

Accumulated sediment on forested wetland surface from detention basin 110

- Remove accumulated sediment in early spring by hand shovel, metal rakes, and plastic buckets/pails from forested wetland. No machinery shall be used to complete the sediment removal.
- Dispose of excavated sediment in upland area.

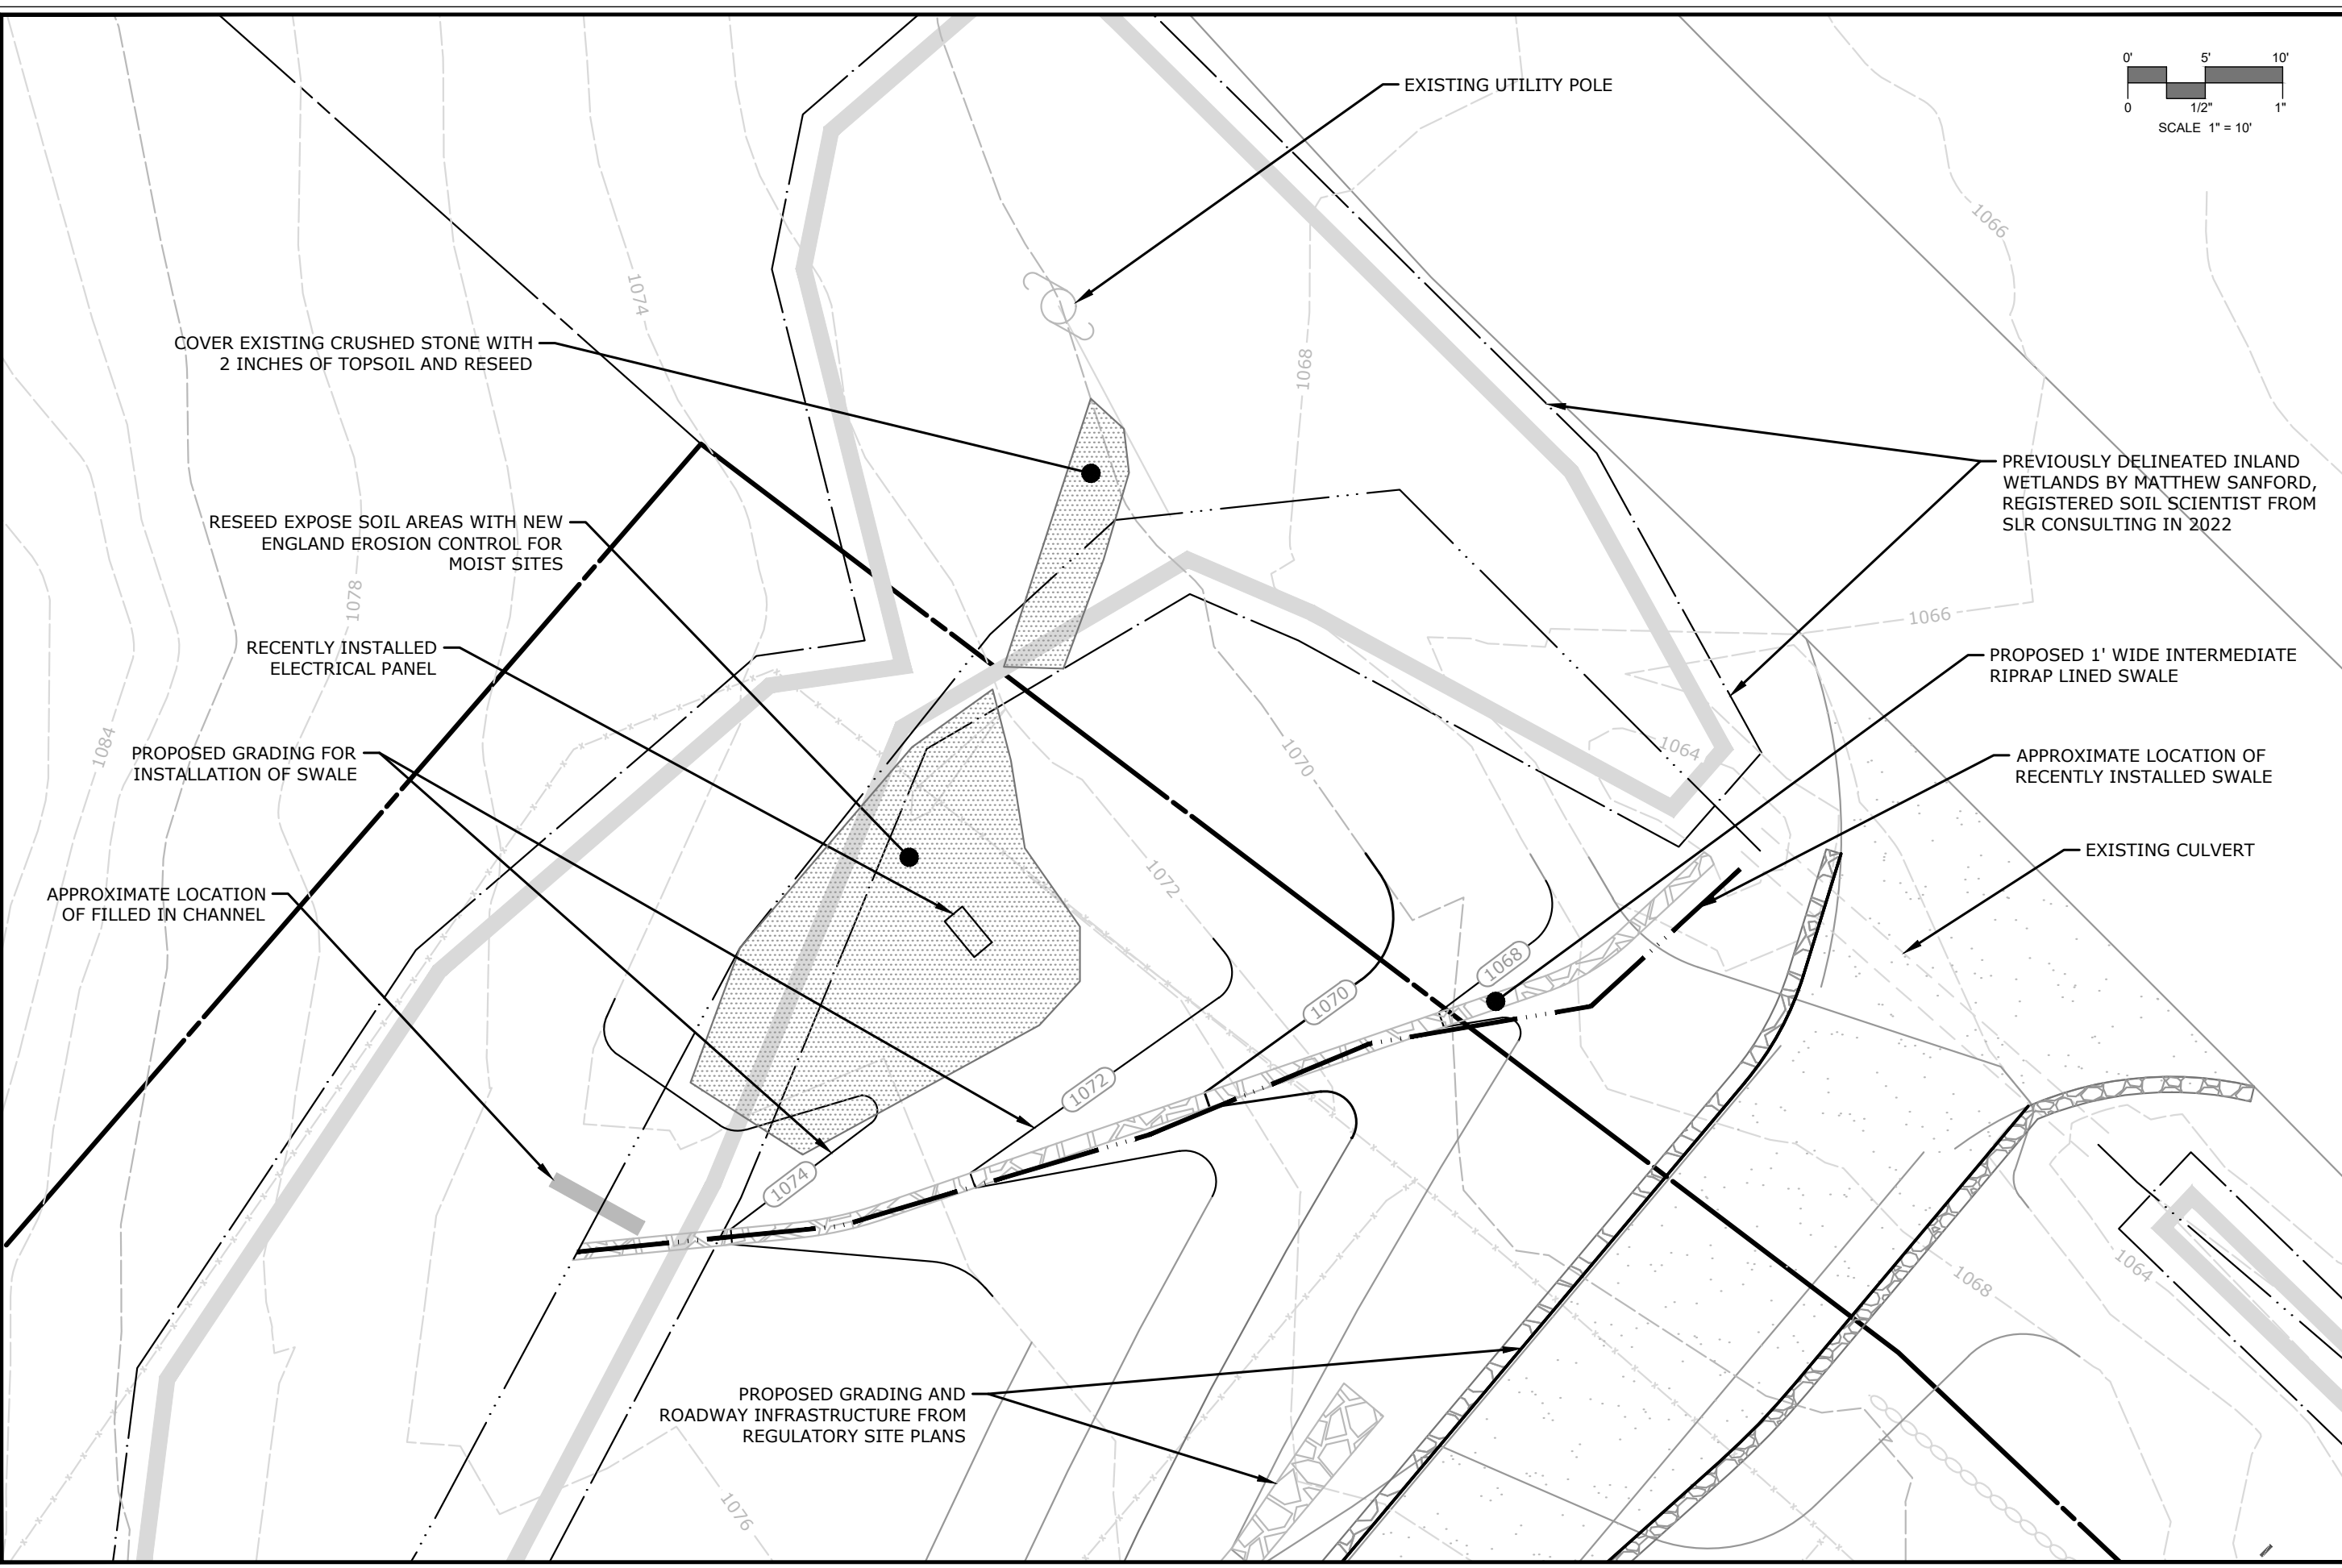
FIGURE 1

APPROXIMATE LOCATION OF FILLED IN CHANNEL

APPROXIMATE LOCATION OF RECENTLY INSTALLED SWALE

COVER EXISTING CRUSHED STONE WITH 2 INCHES OF TOPSOIL AND RESEED

RESEED EXPOSE SOIL AREAS WITH NEW ENGLAND EROSION CONTROL FOR MOIST SITES

PROPOSED 1' WIDE INTERMEDIATE RIPRAP LINED SWALE
