October 14, 2022

**Re: WETLANDS INVESTIGATION – SUMMARY OF FINDINGS**  
Haynes Materials, Winsted Road, Torrington, CT

*REMA Job No.: 22-2519-TOR8*

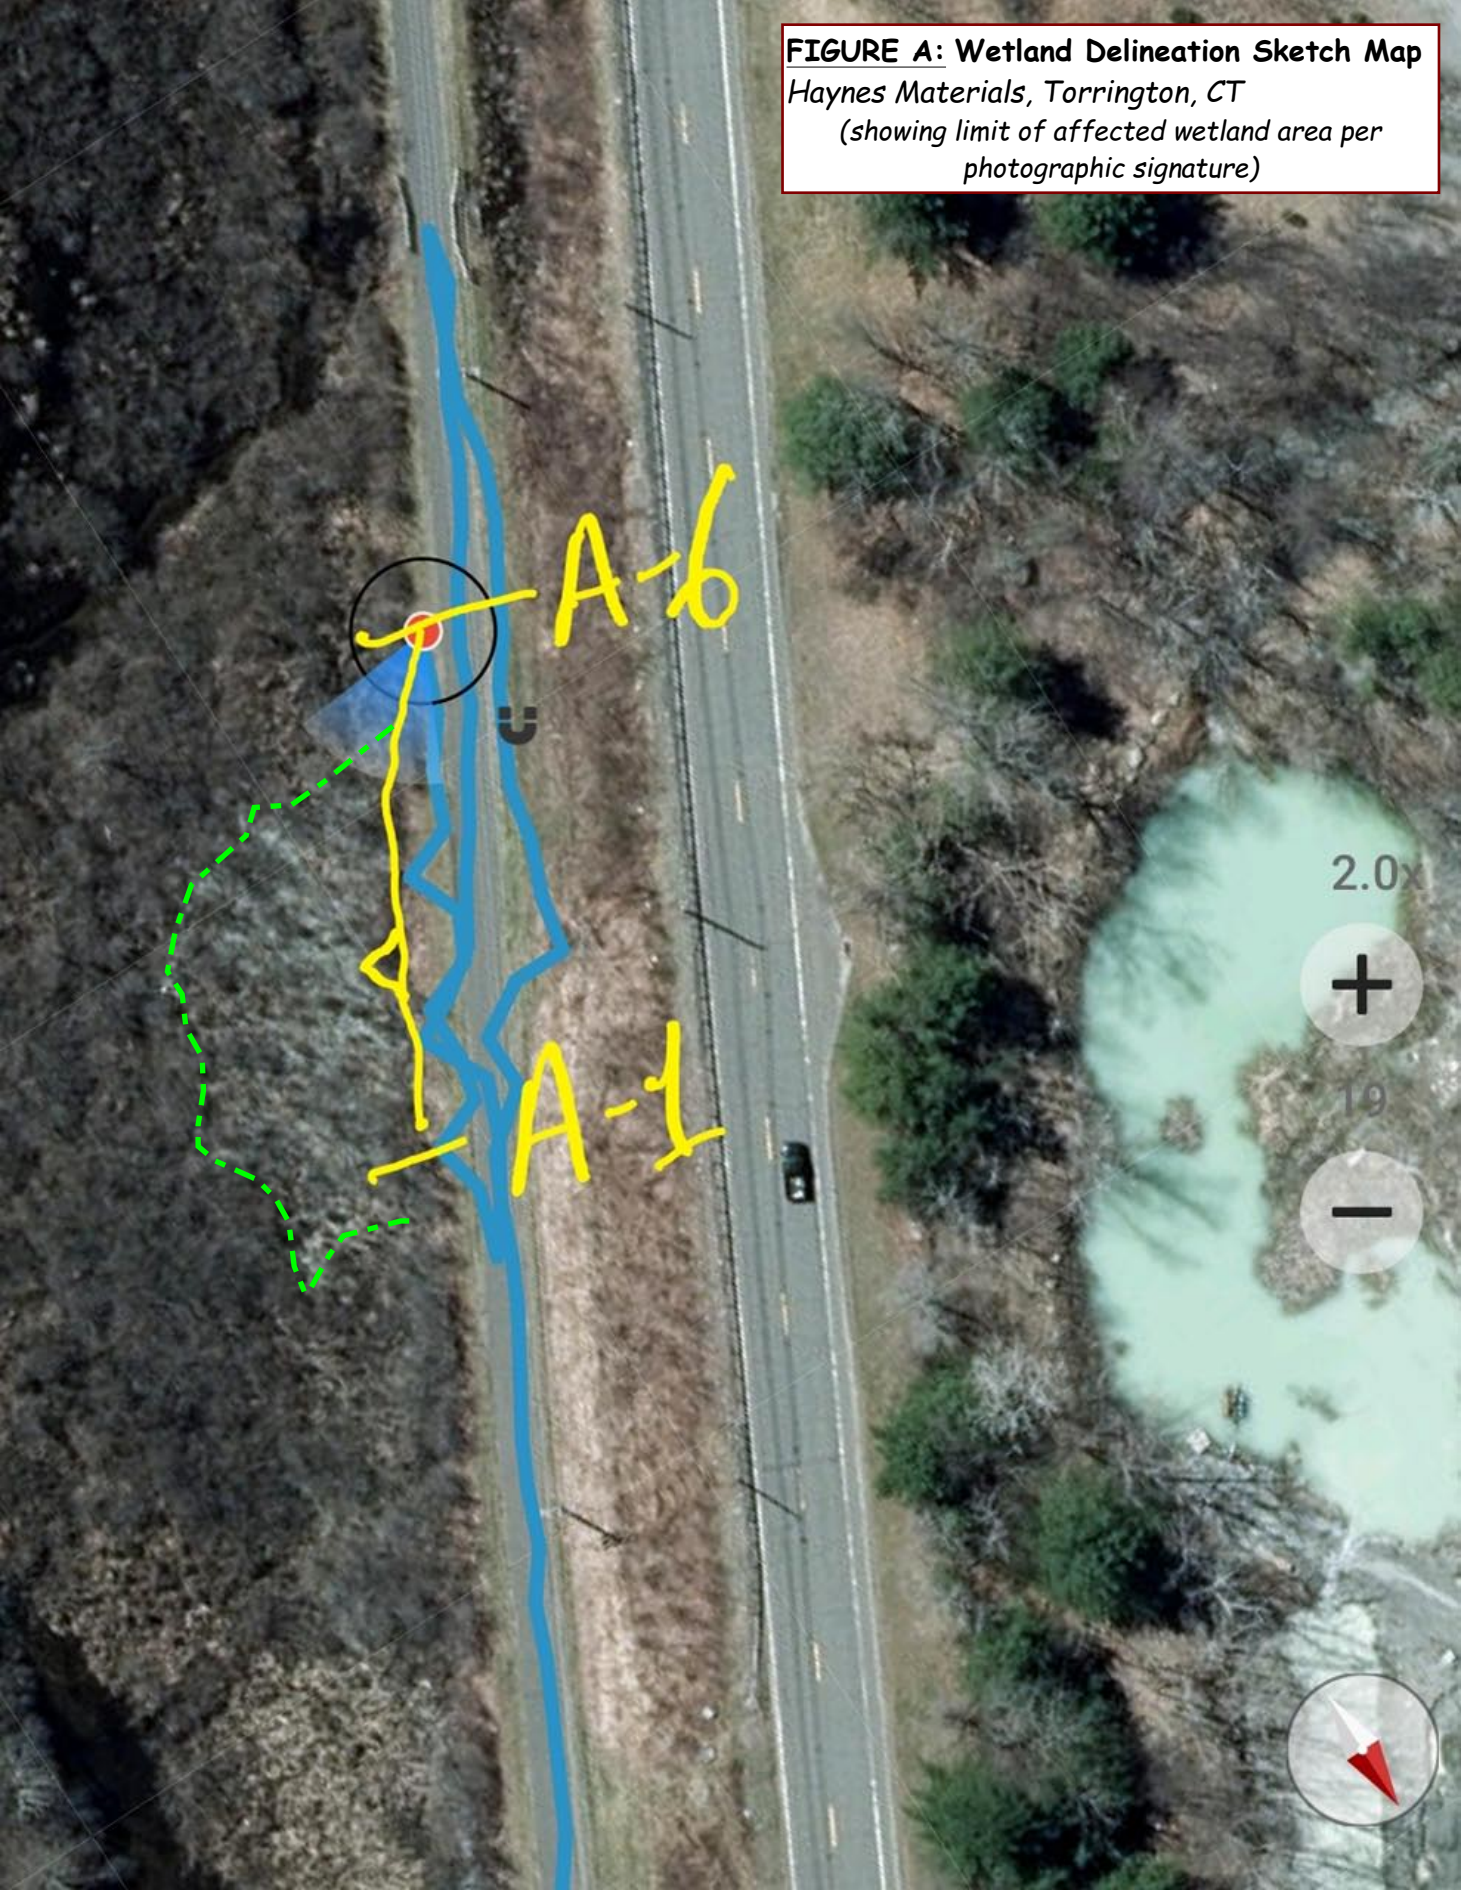
**FIGURE A: Wetland Delineation Sketch Map**  
*Haynes Materials, Torrington, CT*  
(showing limit of affected wetland area per  
photographic signature)

The study area encompasses roughly 0.5 acres immediately to the east of the rails to trails linear park, located just east of Winsted Road (see attached USDA-NRCS Web Soil Survey). It is within a property owned by AVI Land Development, LLC, at 3240 Winsted Road. The entire study area is characterized as a regulated wetland area, and its western boundary was delineated (Survey Flags RES-A-1 to RES-A-6) (see Figure A, attached).

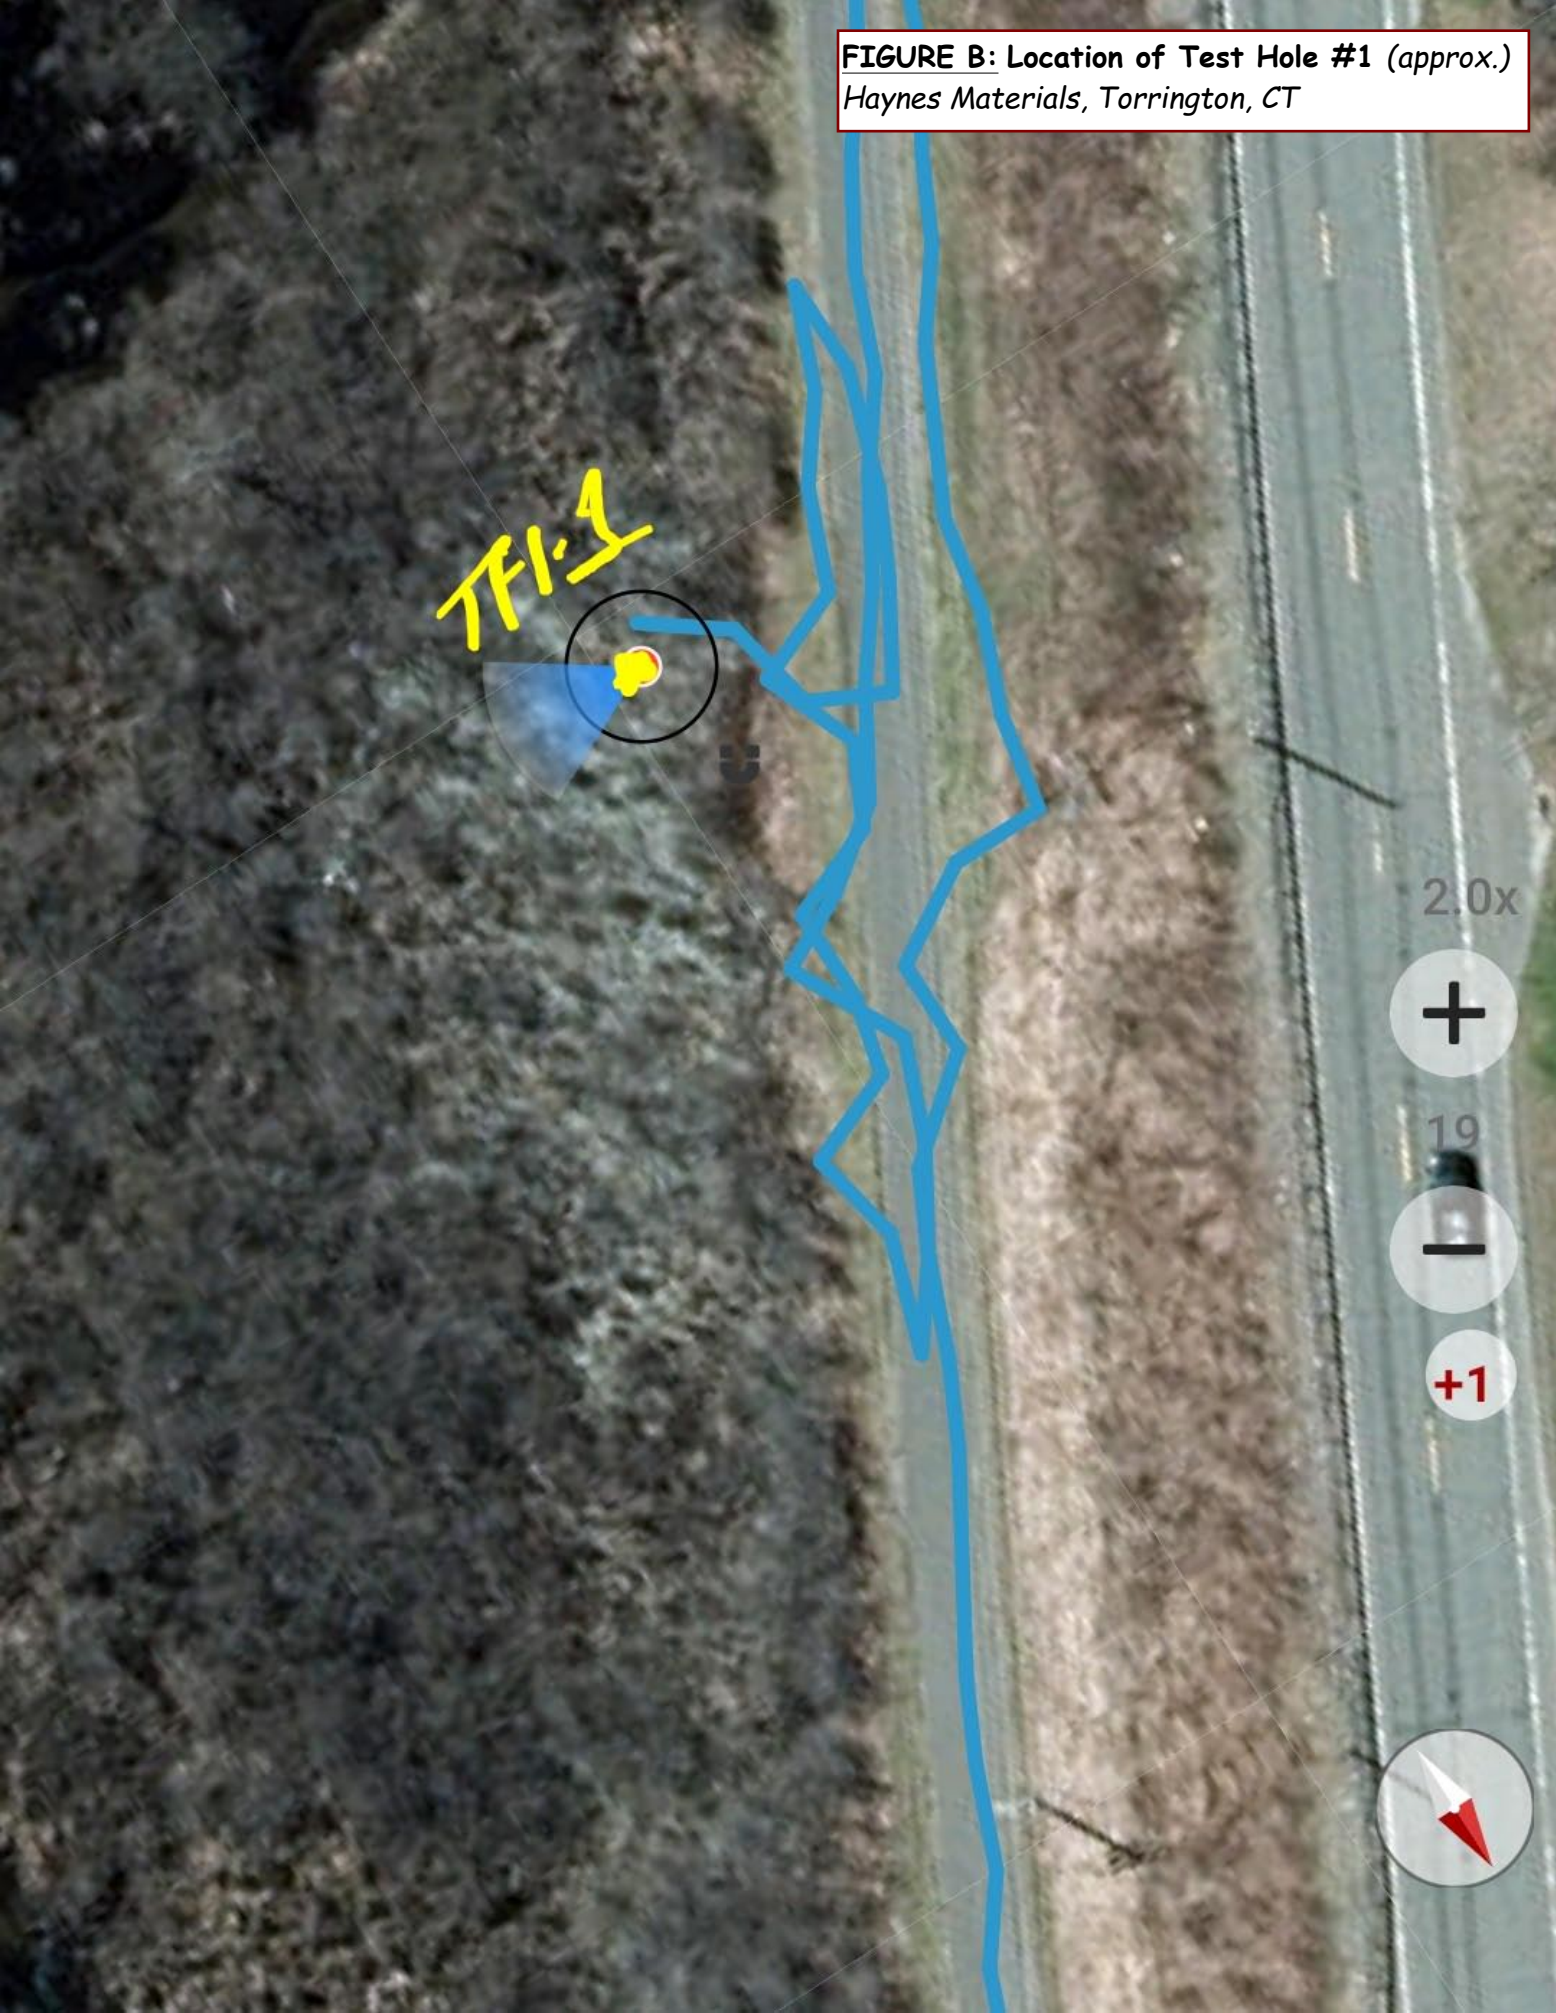
**FIGURE B: Location of Test Hole #1 (approx.)**  
*Haynes Materials, Torrington, CT*

Test Hole #1 = 9" sediment; saturated to surface

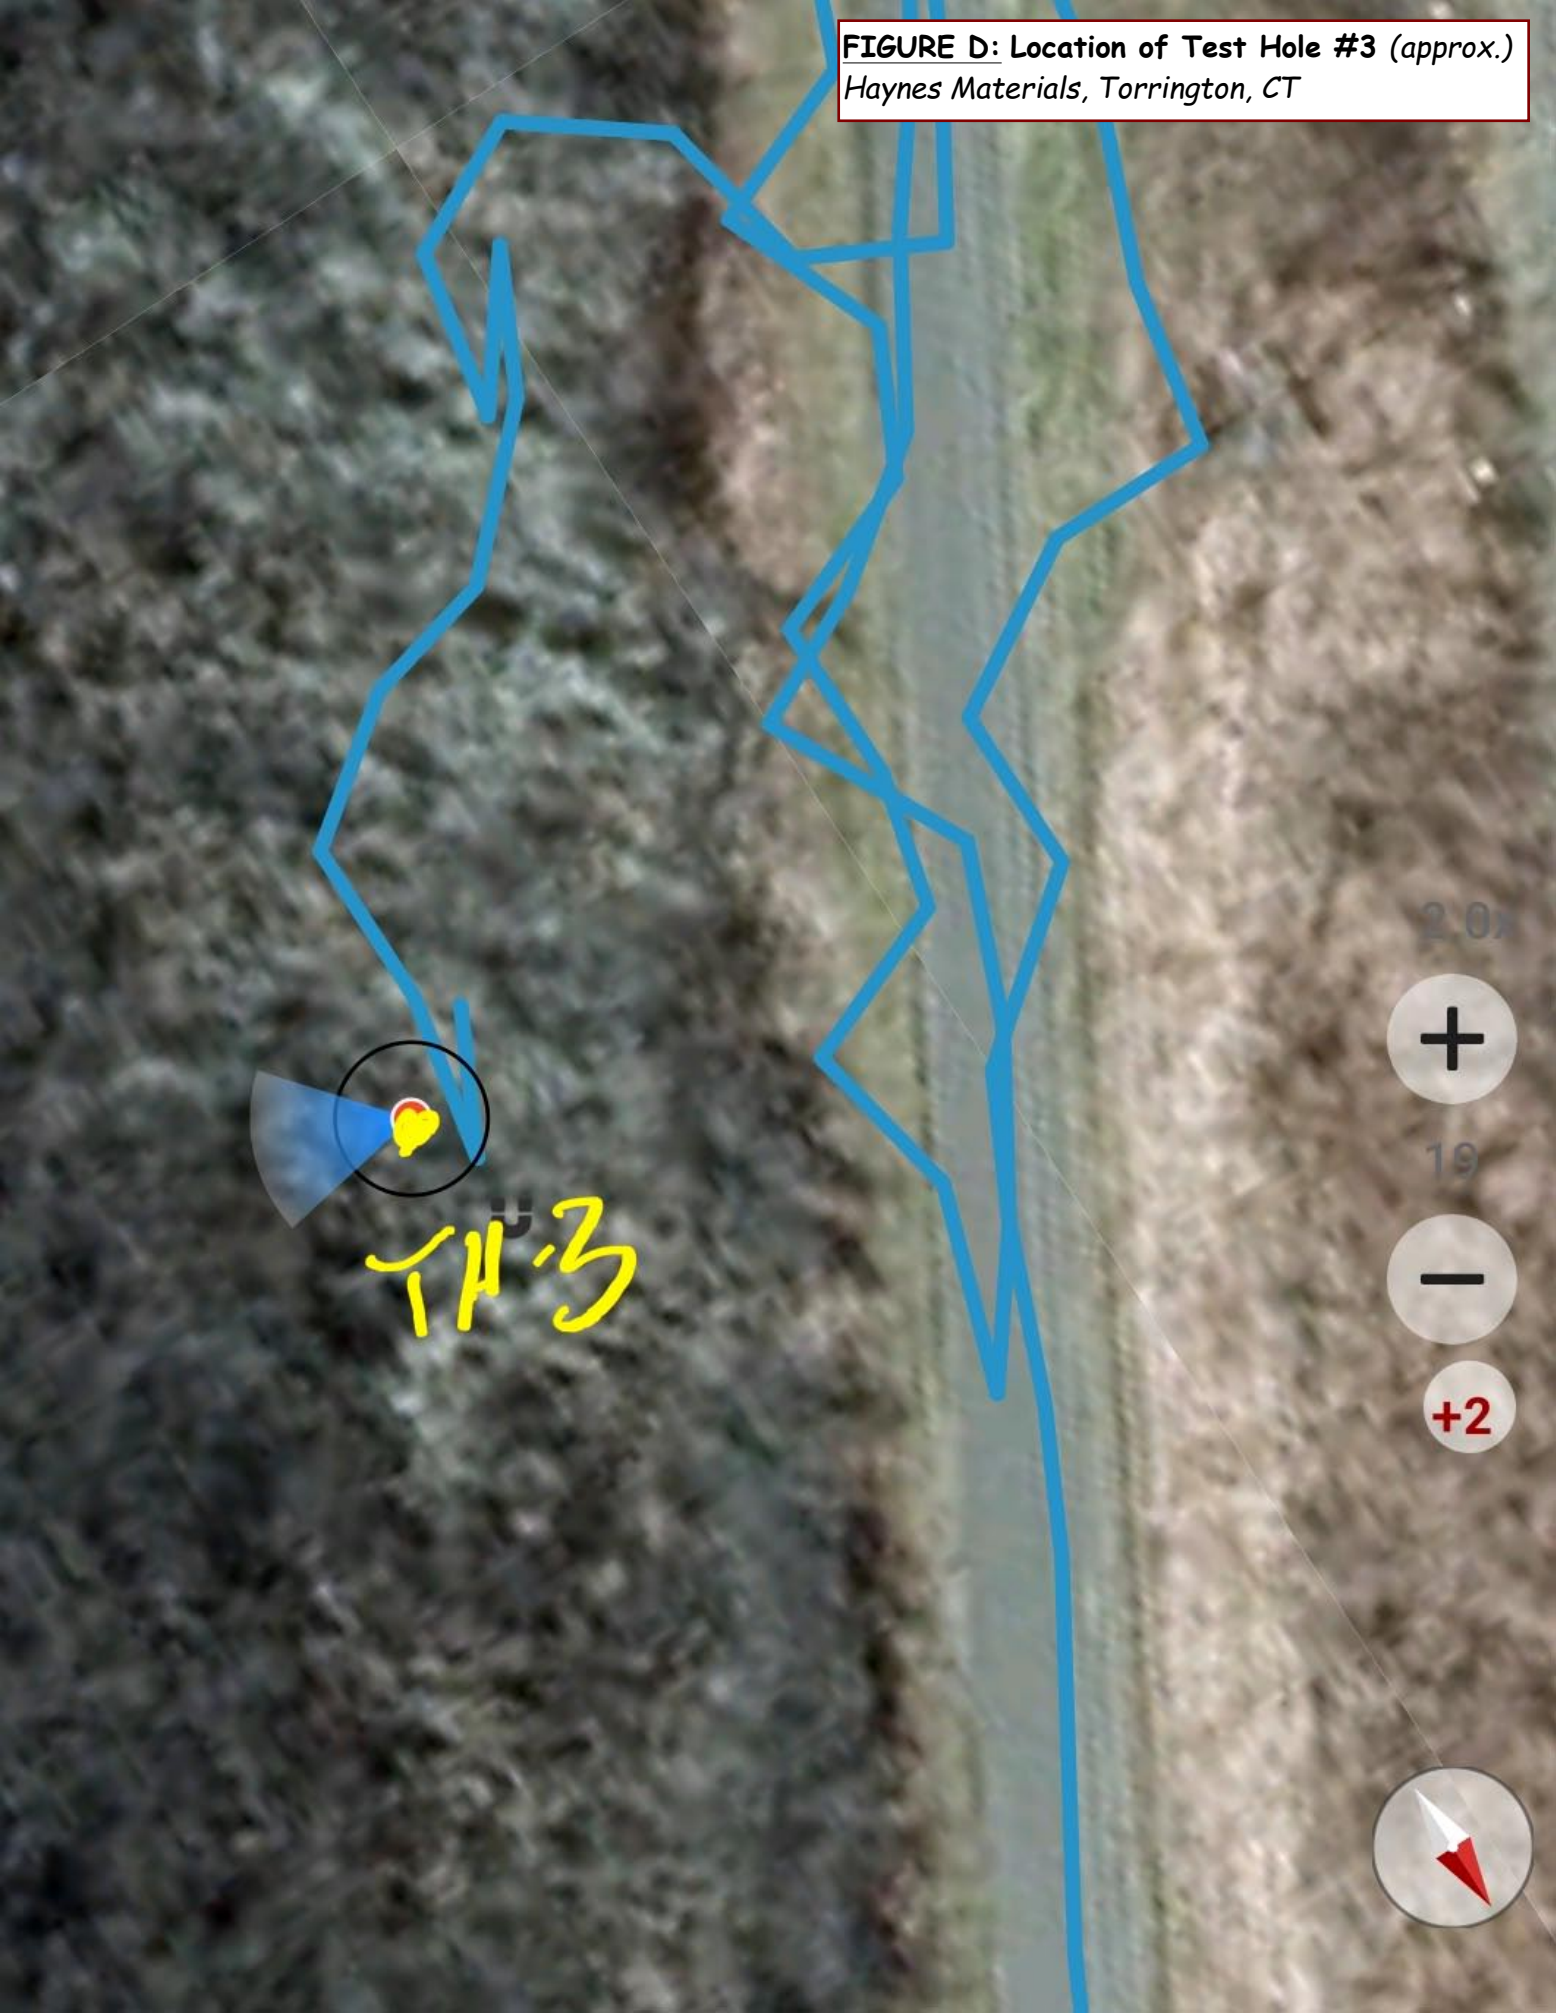
**FIGURE D: Location of Test Hole #3 (approx.)**  
*Haynes Materials, Torrington, CT*

Test Hole #3 = 20" sediment over 22"+ muck; saturated to surface

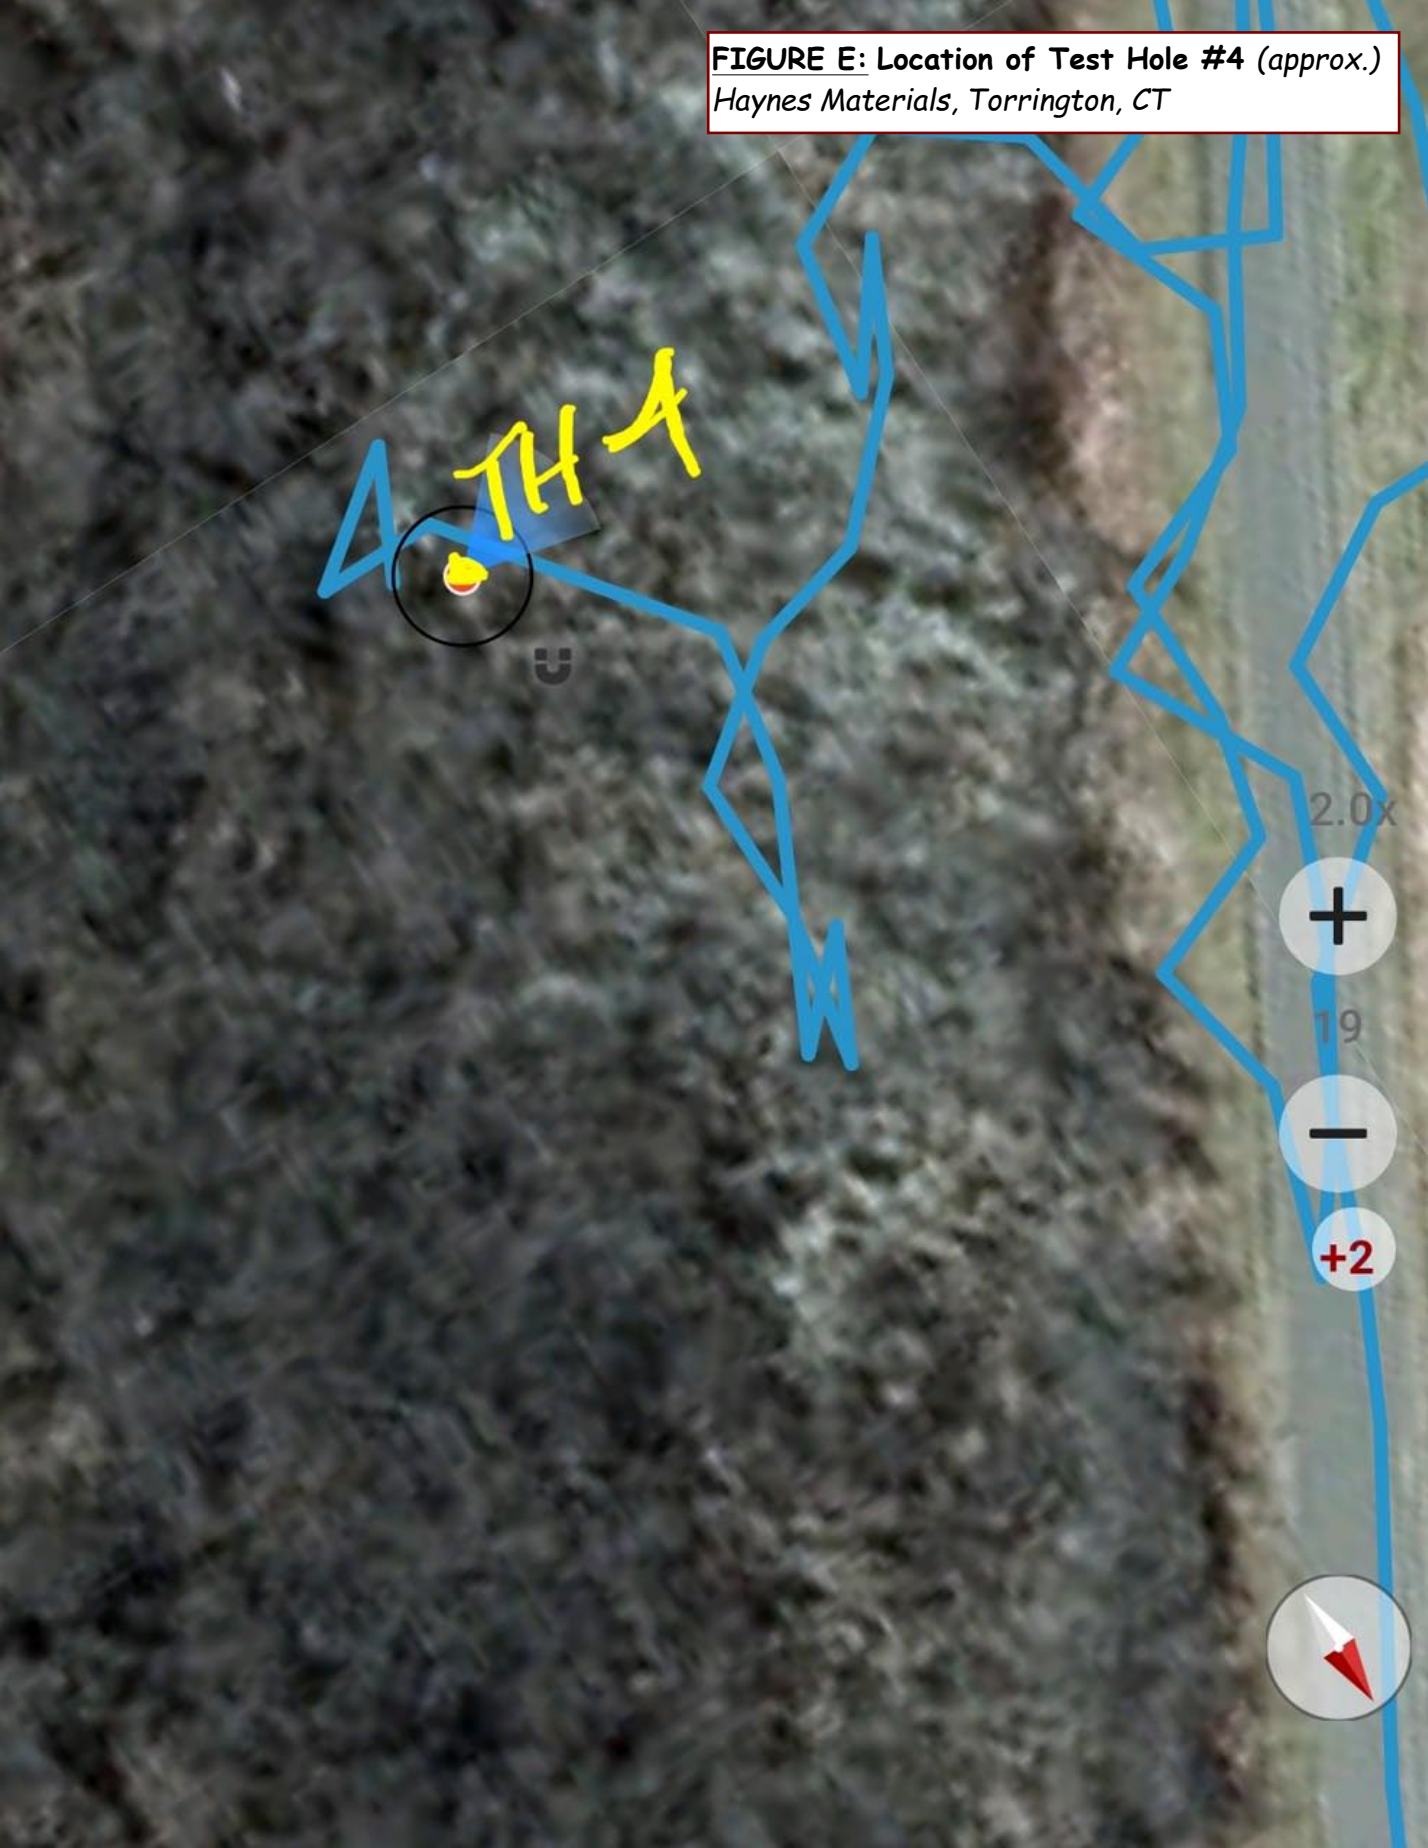
**FIGURE E: Location of Test Hole #4 (approx.)**  
*Haynes Materials, Torrington, CT*

Test Hole #4 = 7" sediment; saturated to surface; near edge of sediment deposition

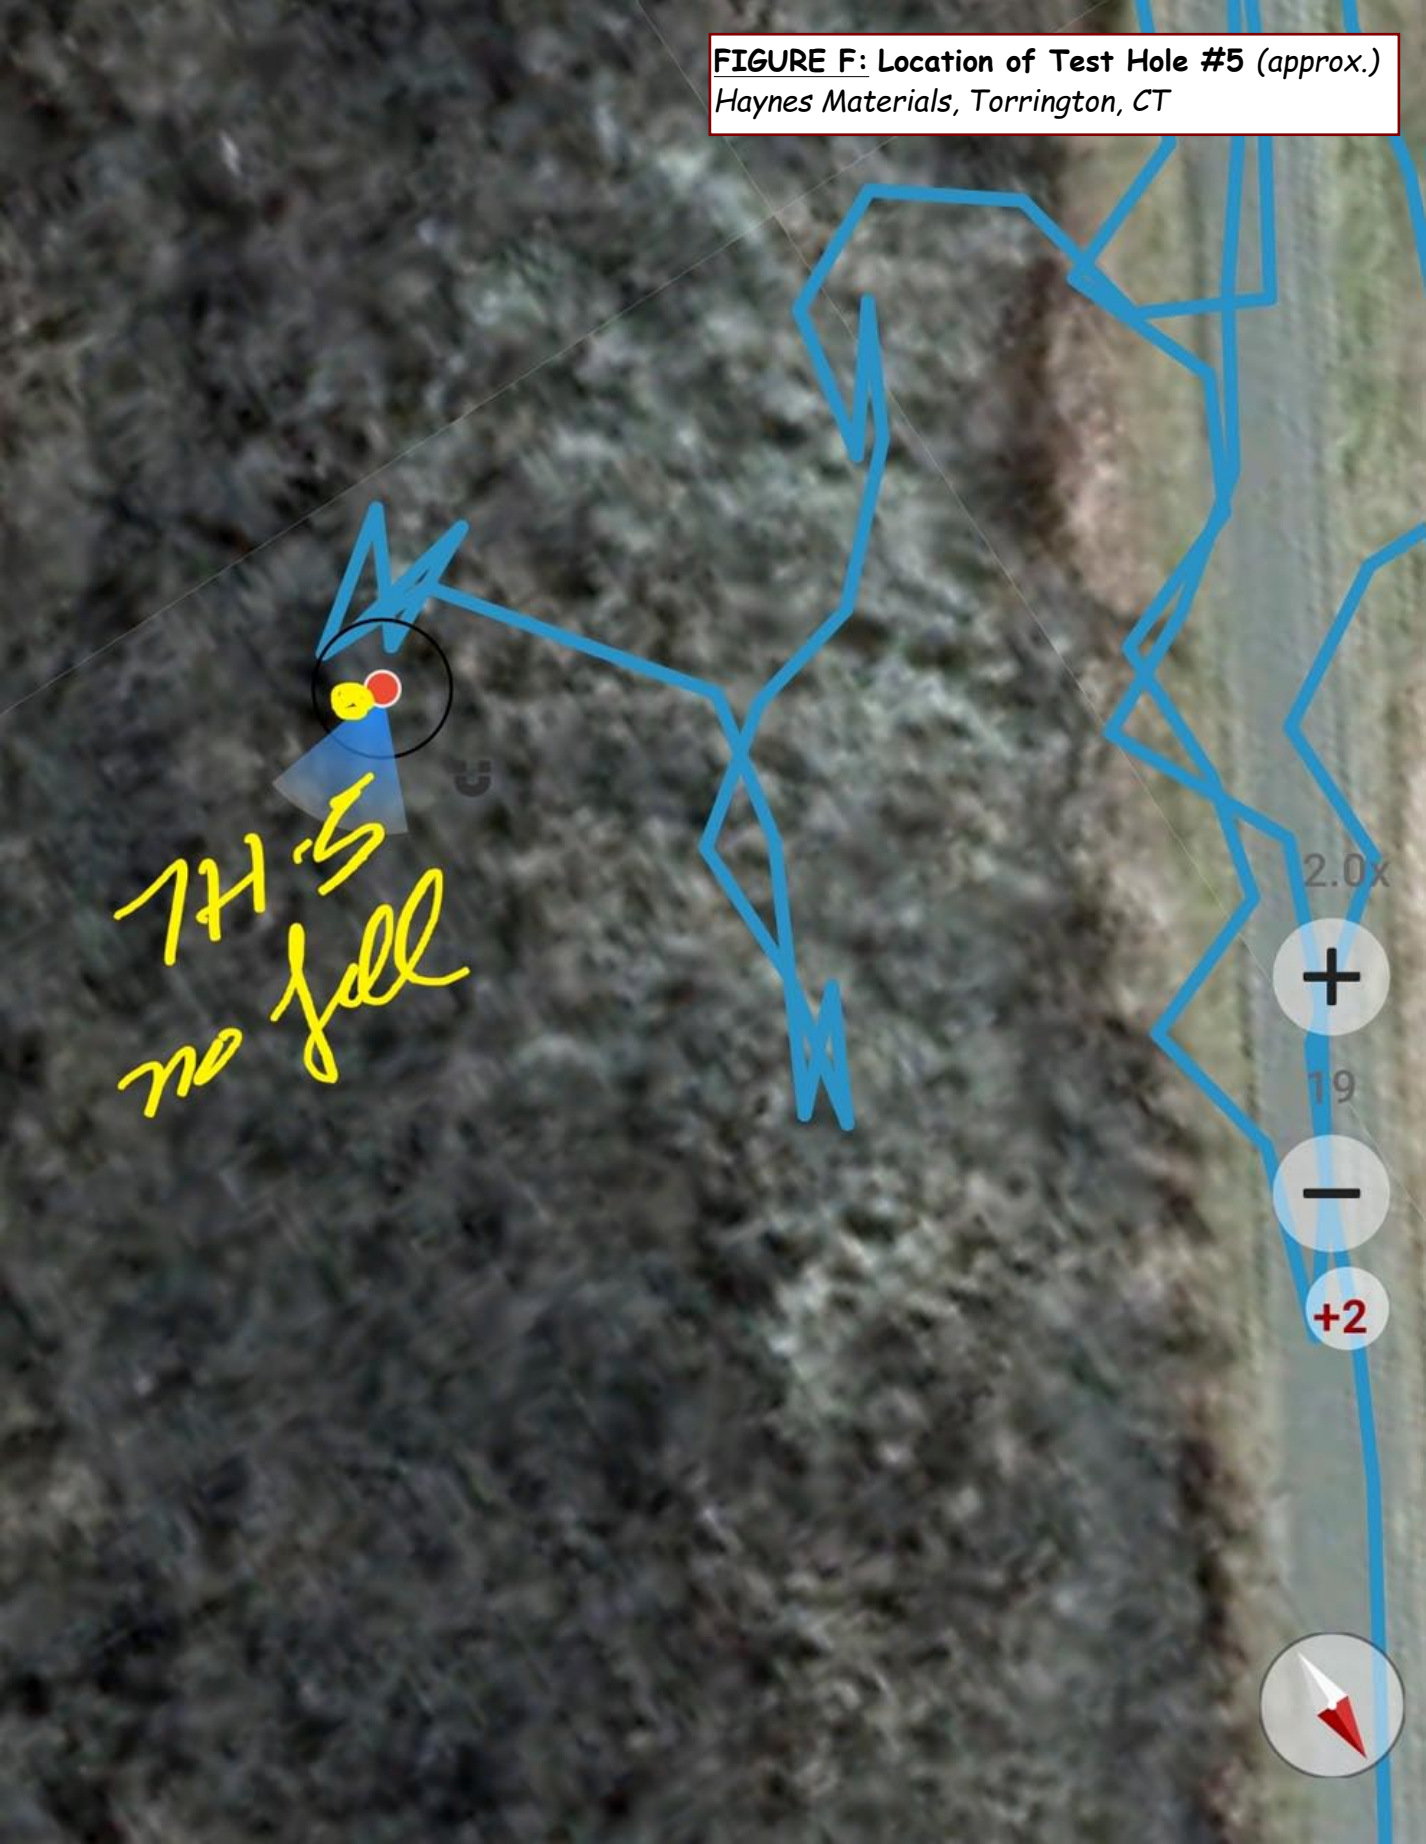
**FIGURE F: Location of Test Hole #5 (approx.)**  
*Haynes Materials, Torrington, CT*

Test Hole #5 = 0" sediment; saturated to surface; within 12' of small (2' wide) watercourse

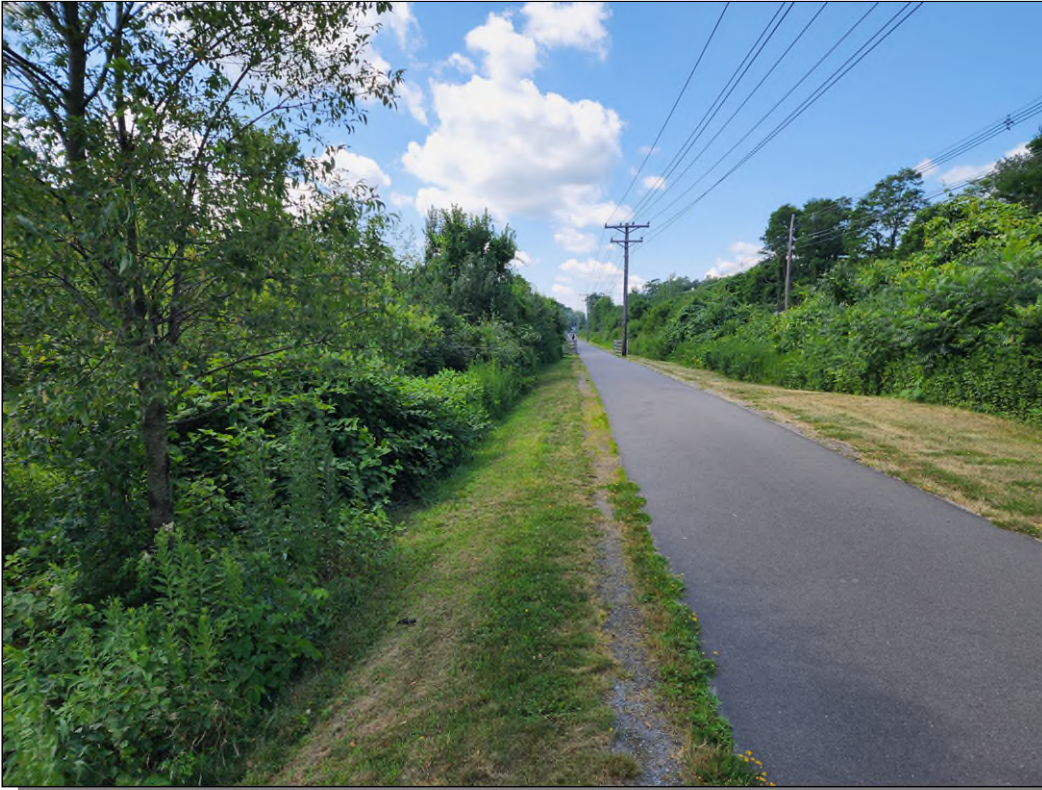
*Photo 1:* Wetlands (to left; east), associated with northerly flowing Still River, along a roughly 250-foot portion of the “rails to trails” linear park; facing southwesterly

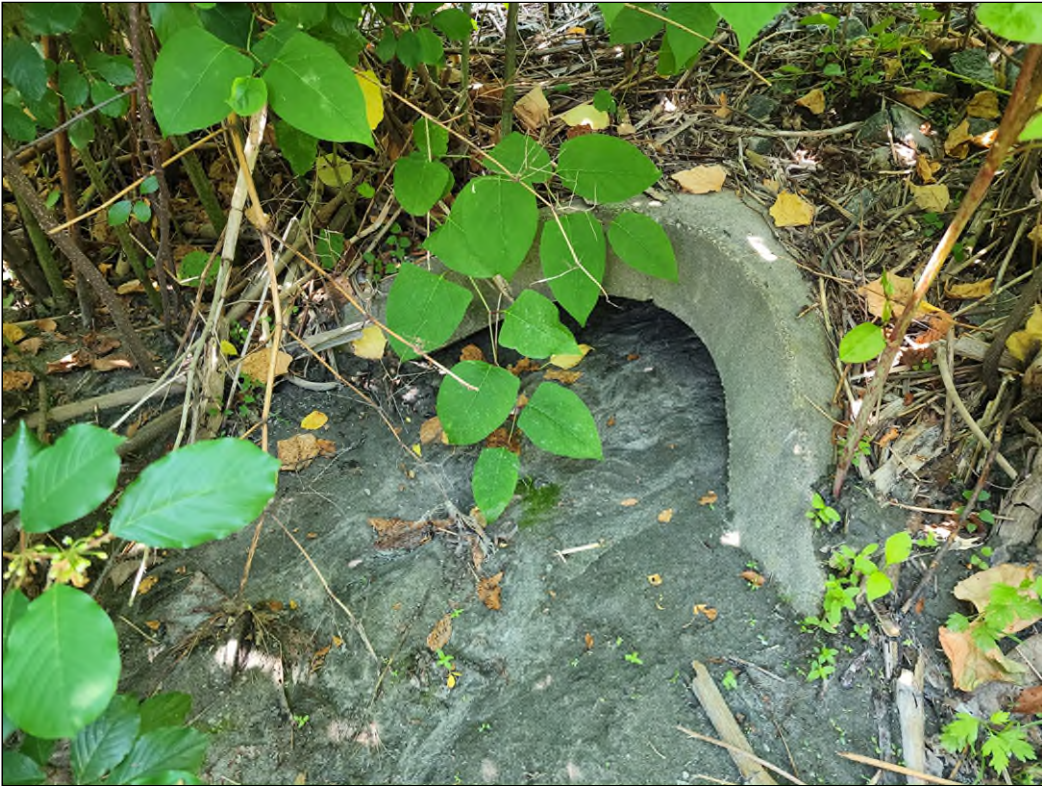
*Photo 2:* Mostly filled-in culvert under Winsted Road and linear park, that has brought very fine stone dust tailings to riparian wetland; facing westerly

For the above-stated reasons, and based on our field investigations, we do not believe it to be prudent that any deposited sediment be removed, but that measures be taken so that no more sediment deposition takes place. The only recommendation we would make is that the source of the tailings be remediated, so that it does not continue affecting this area in the future. It is our understanding that this has already taken place.

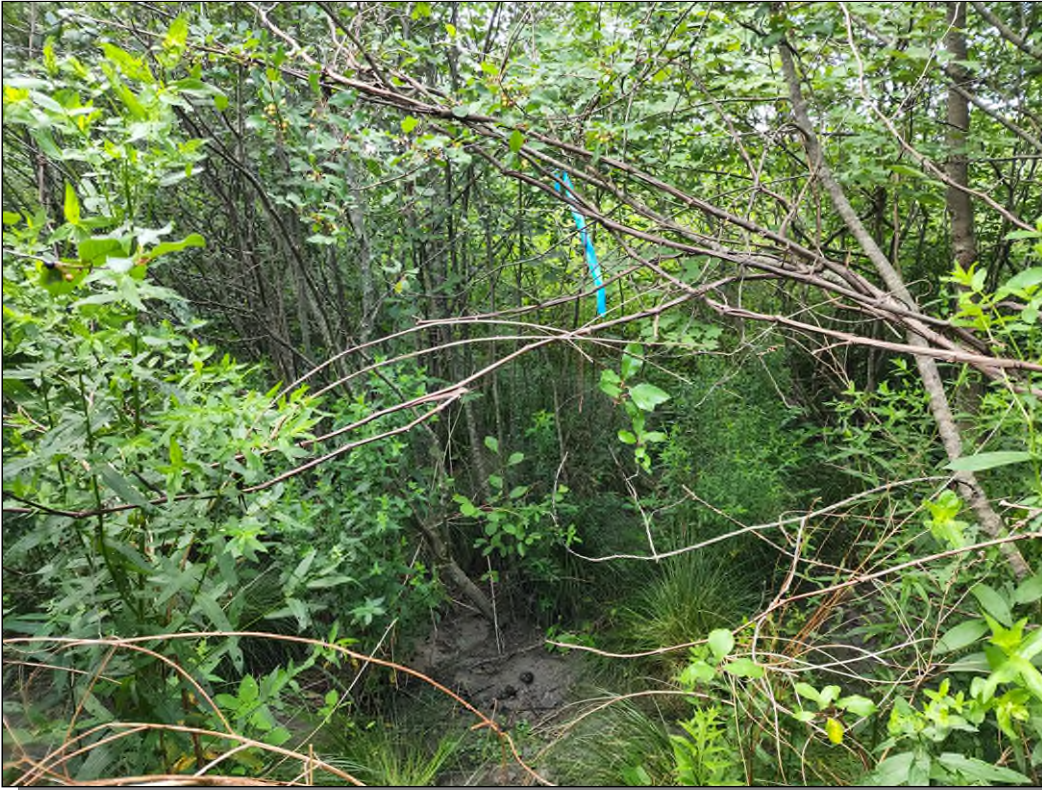
*Photo 3: Test Hole & Plot #1; facing northerly*

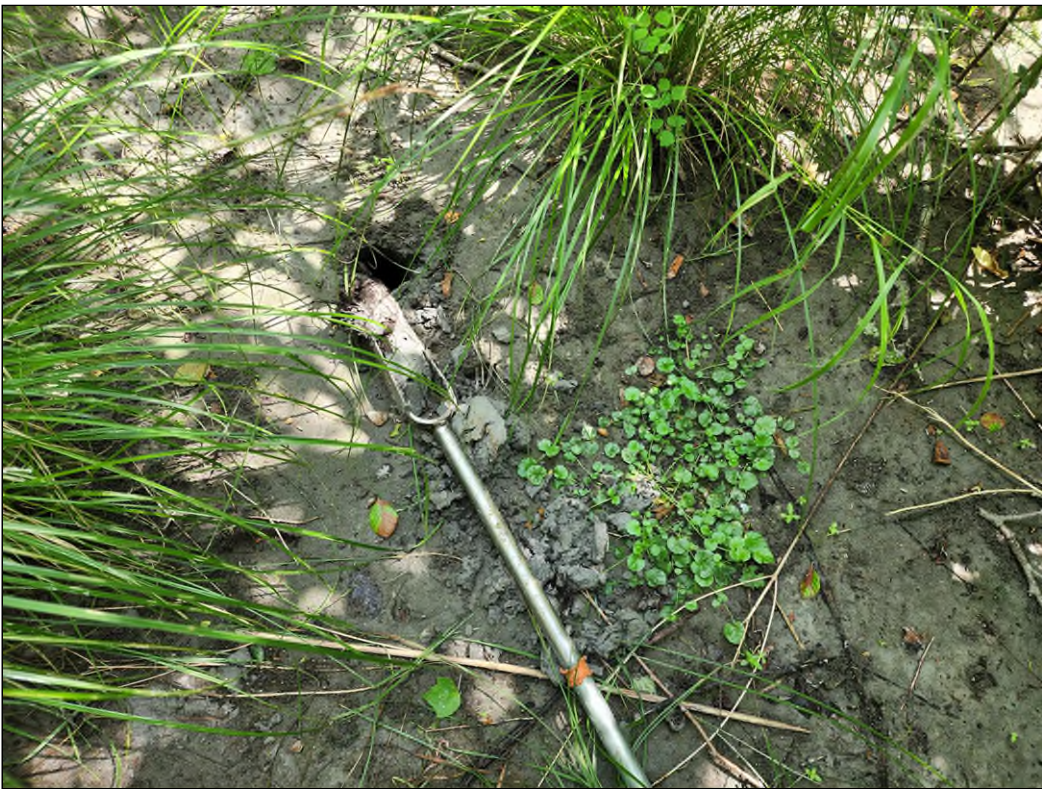
*Photo 4: Sediment deposition above original deep organics (muck) soils was measured at each test hole (here Test Hole #1)*

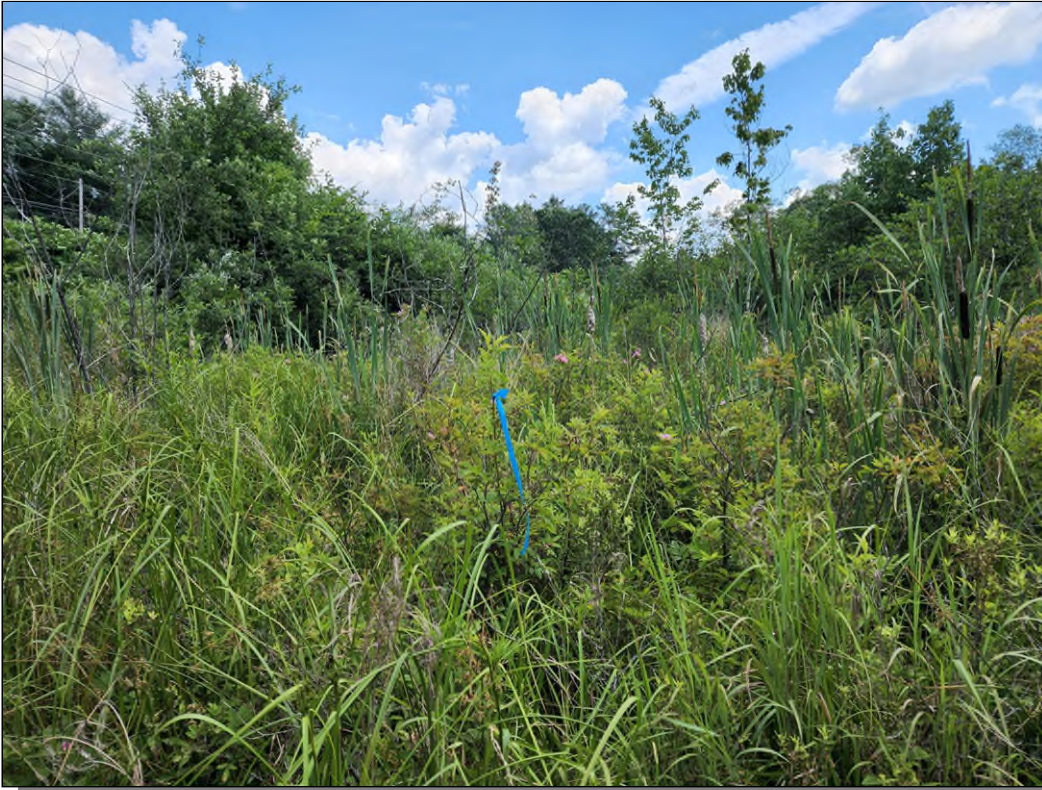
*Photo 5:* Test Hole & Plot #2; facing northerly

Test Hole #2 = 18" sediment; saturated to surface

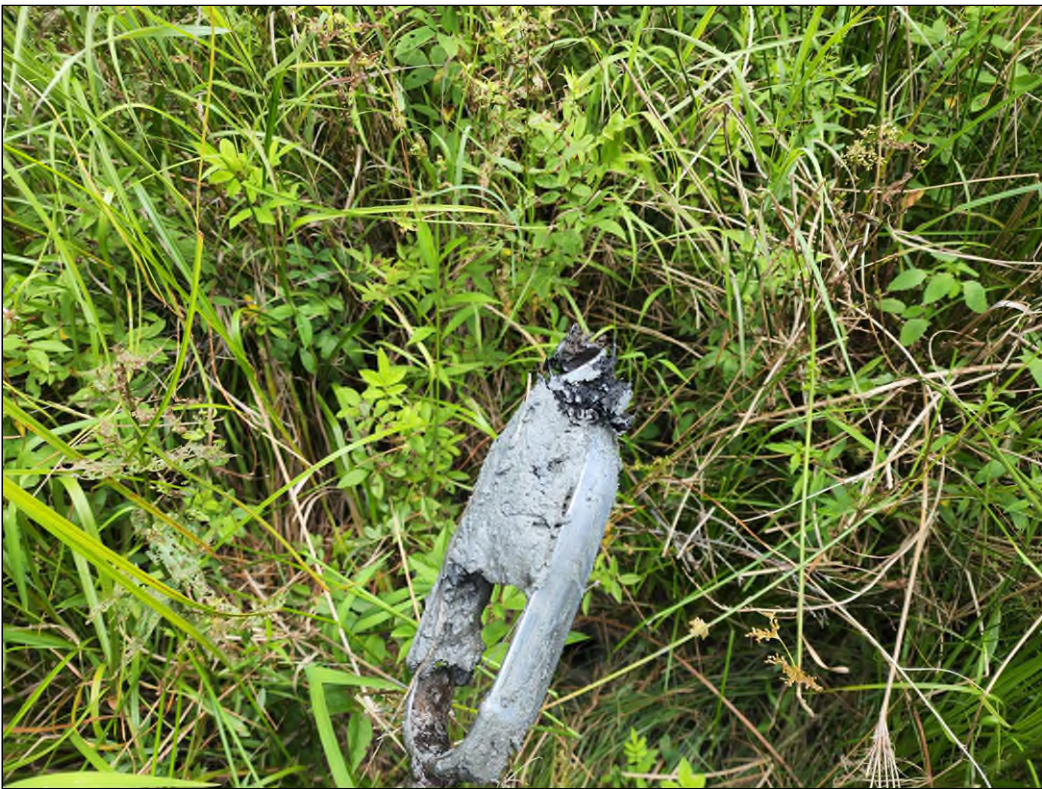
*Photo 6:* Sediment deposition above original deep organics (muck) soils was measured at each test hole (here Test Hole #2)

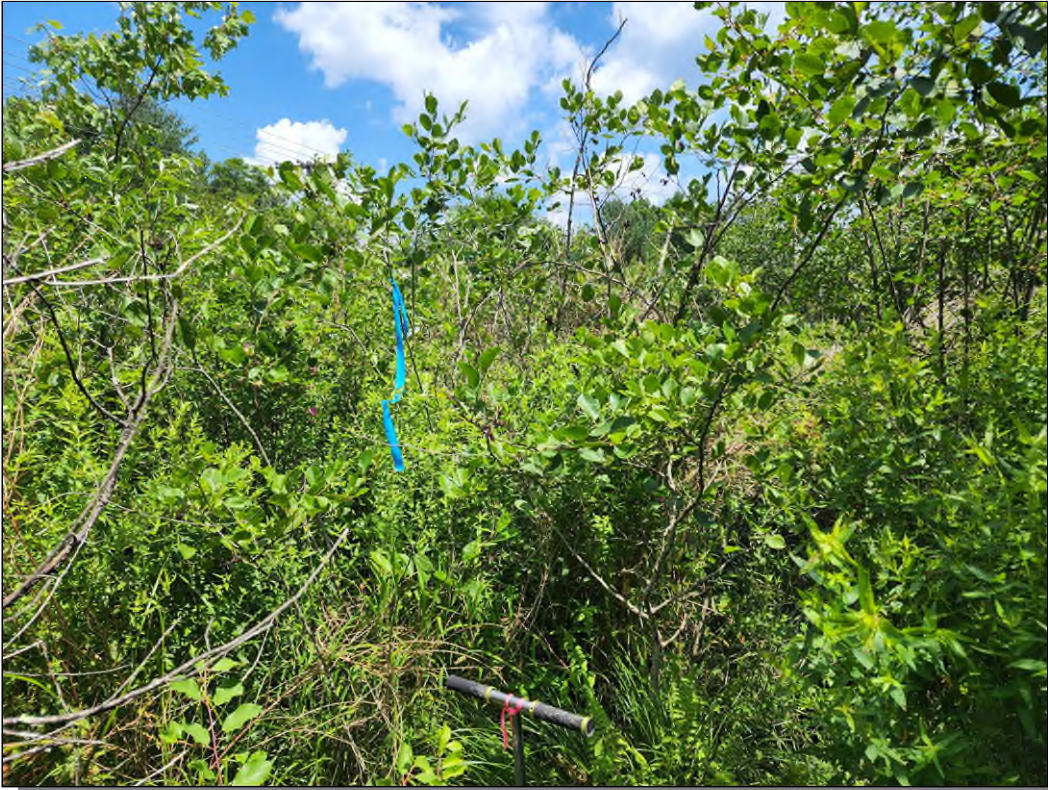
*Photo 7: Test Hole & Plot #3; facing westerly*

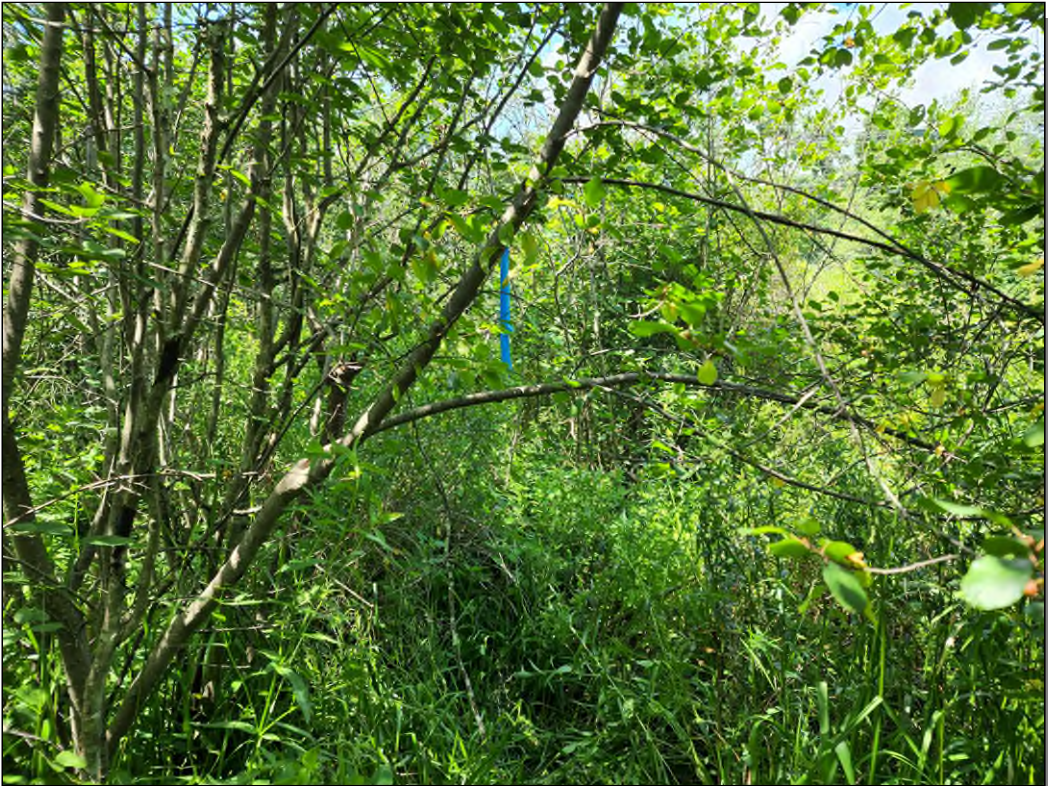
*Photo 8: Test Hole & Plot #4; facing westerly*

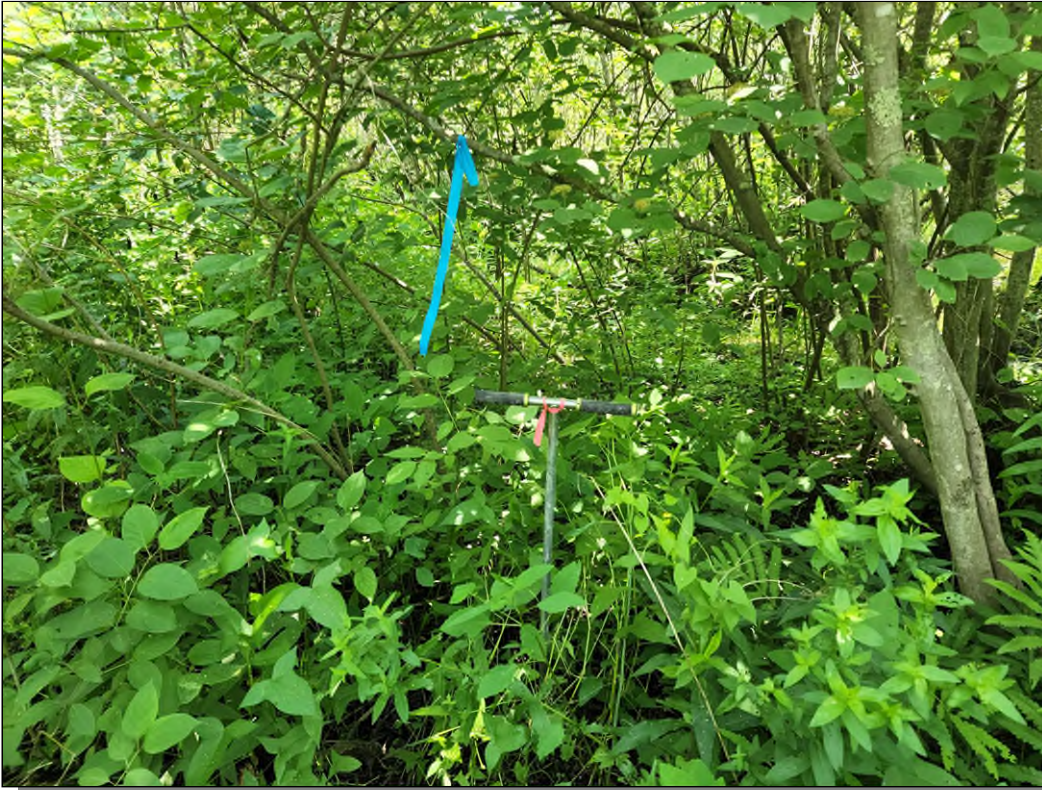
*Photo 9: Test Hole & Plot #5; facing northeasterly*

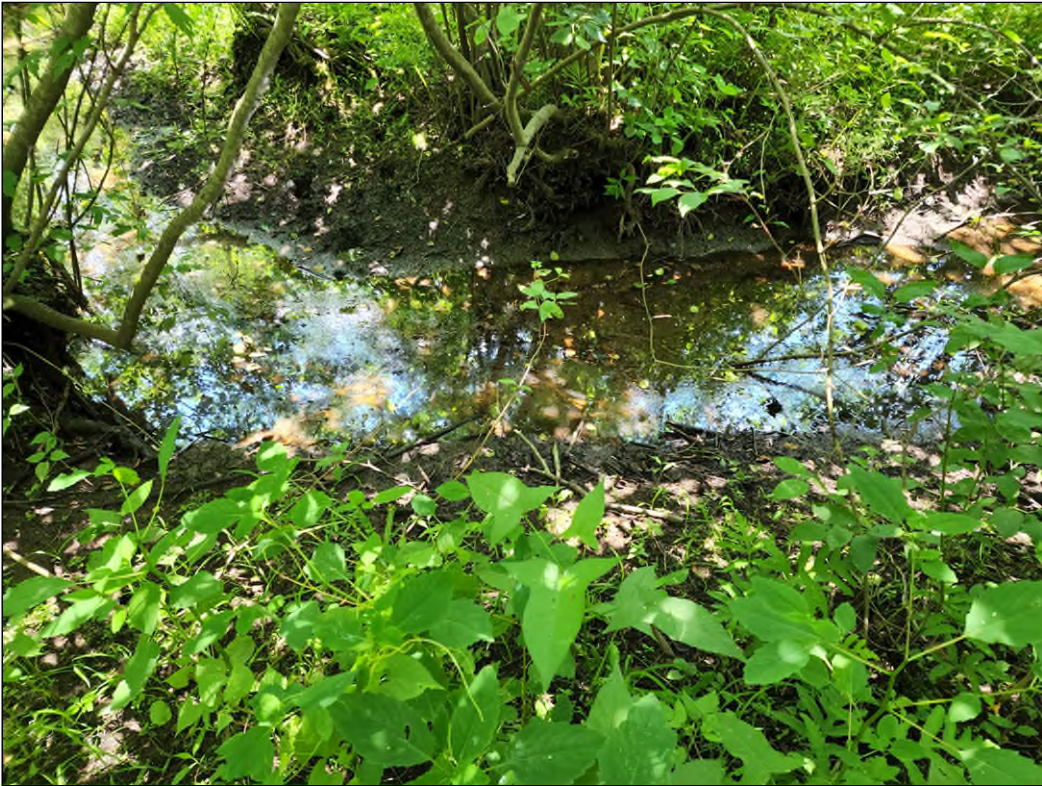
*Photo 10: Intermittent stream channel roughly 12 feet to the east of Plot #5; facing southeasterly*
