October 14, 2022

**Re: WETLANDS INVESTIGATION – SUMMARY OF FINDINGS**  
Haynes Materials, Winsted Road, Torrington, CT

*REMA Job No.: 22-2519-TOR8*

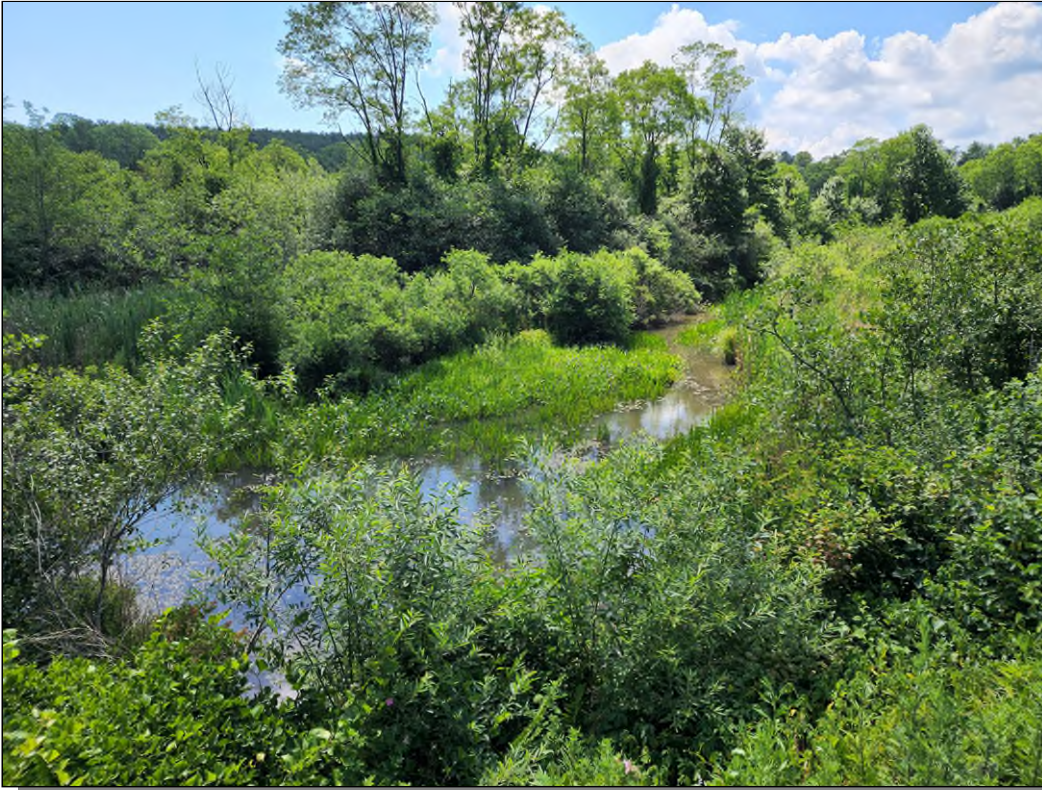
*Photo 11: Still River riparian wetland corridor north (downriver) of the study area; facing southerly*

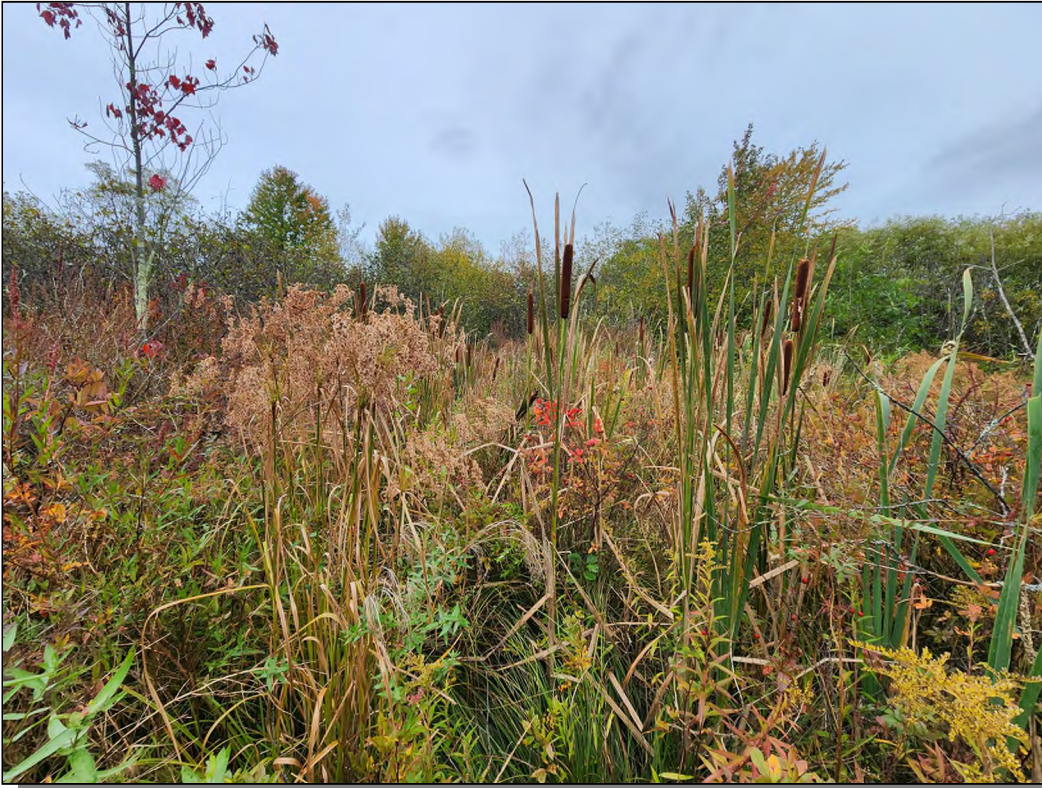
We conclude that, fortunately, the deposition of fine stone dust tailings has not resulted in an adverse impact upon the wetland plant community, although it probably has affected the invertebrate community that relies on the organic soils. Nevertheless, most all of the typical functions and values that the affected wetland area conferred in the past, are still present under existing conditions.

*Photo 12:* Overall view of affected area; robust and diverse emergent vegetation throughout; facing southeasterly

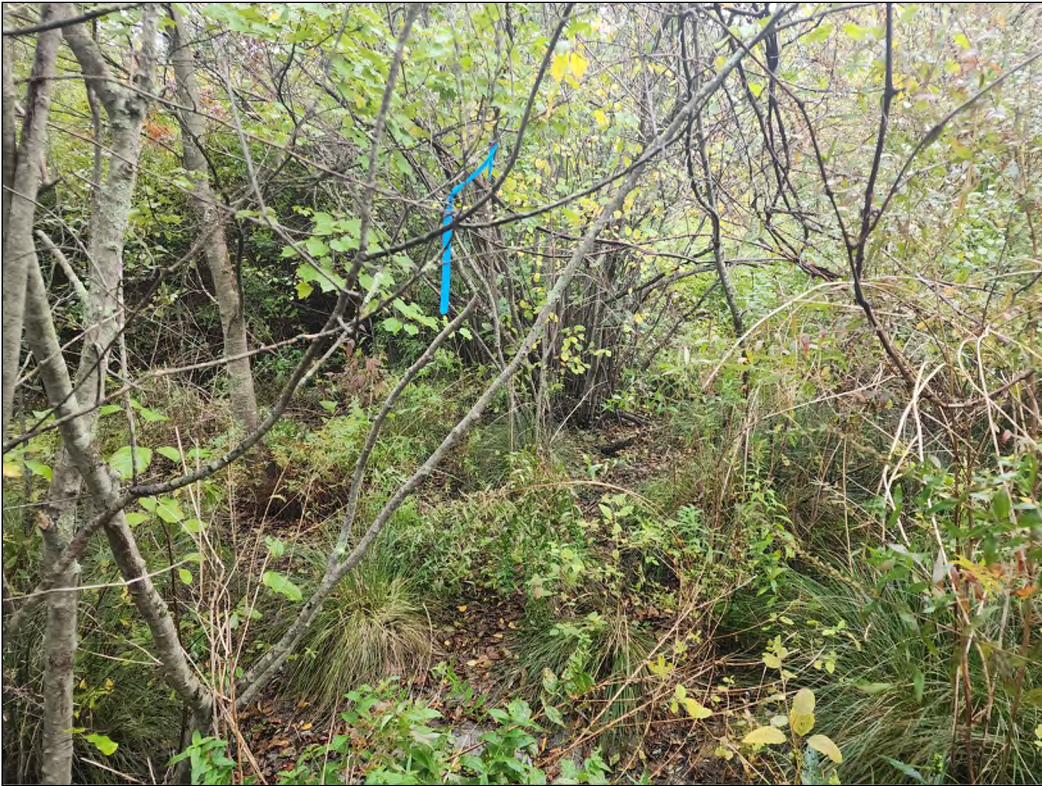
*Photo 13:* Test Hole and Plot #1; facing northwesterly

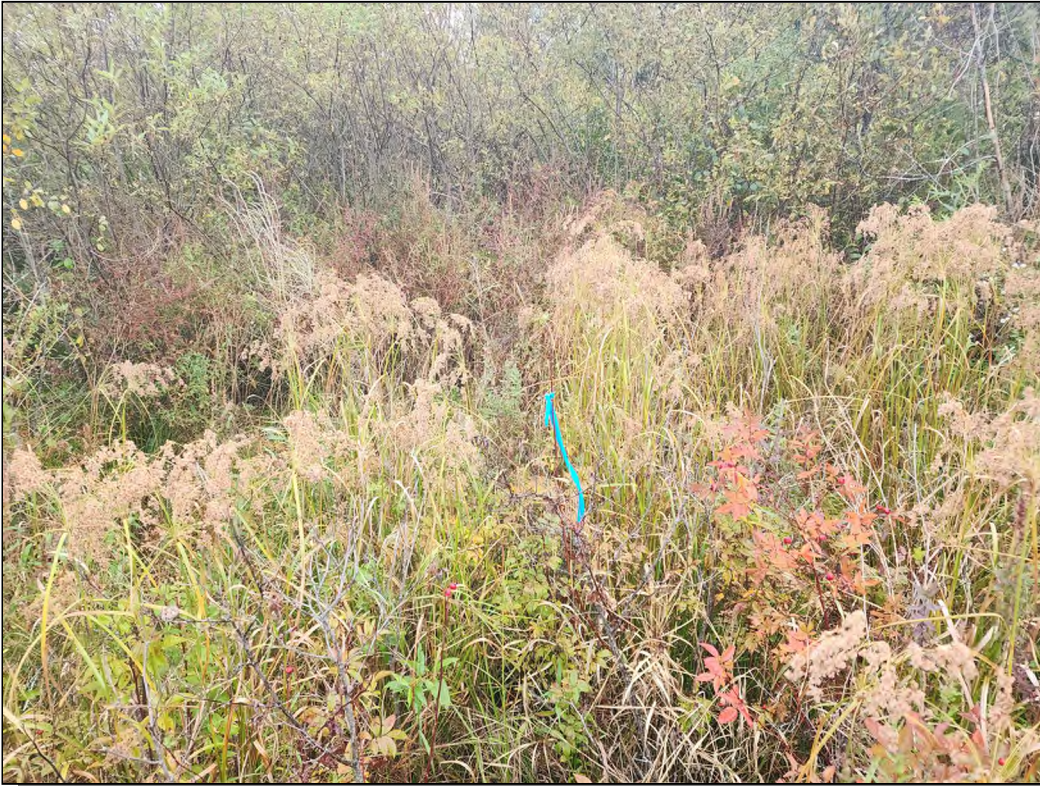
*Photo 14: Test Hole & Plot #2; wool grass (*Scirpus cyperinus*) is now dominant; facing southerly*

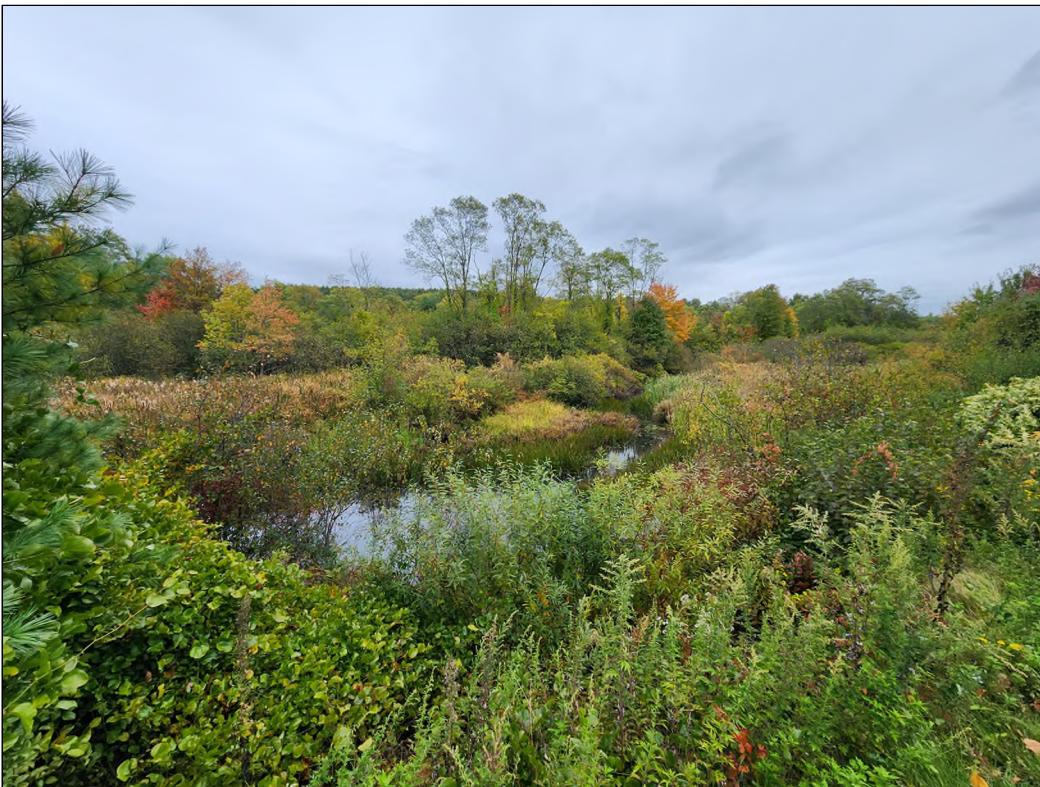
*Photo 15: Still River riparian wetland downstream of study area; facing southeasterly*
